# INSPECTION REPORT

Prepared by: Robert Byrne, License# 16000062890

Higher Elevation Home & Commercial Inspections LLC  
188 Brown Street  
Sea Cliff, NY 11579  
(516) 509- 9091

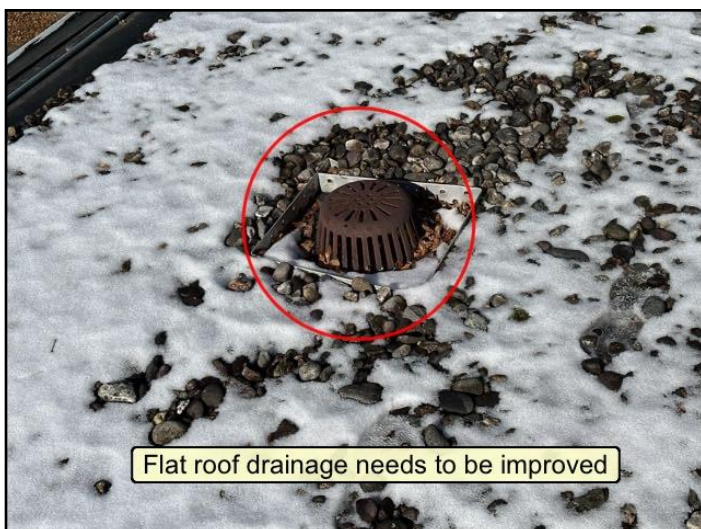
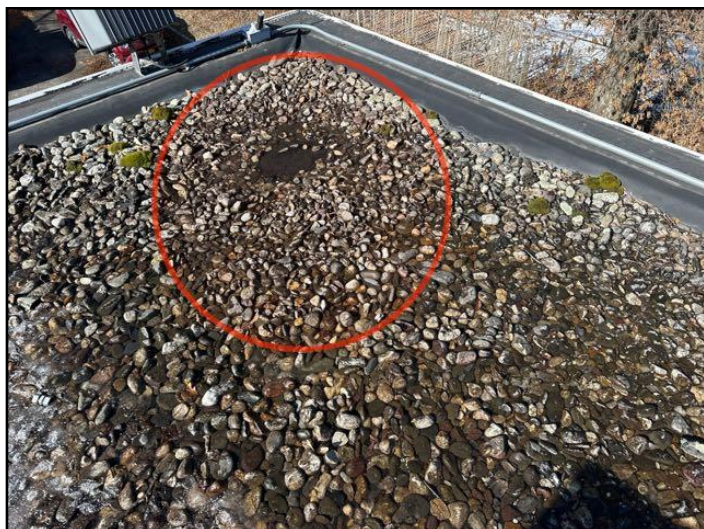
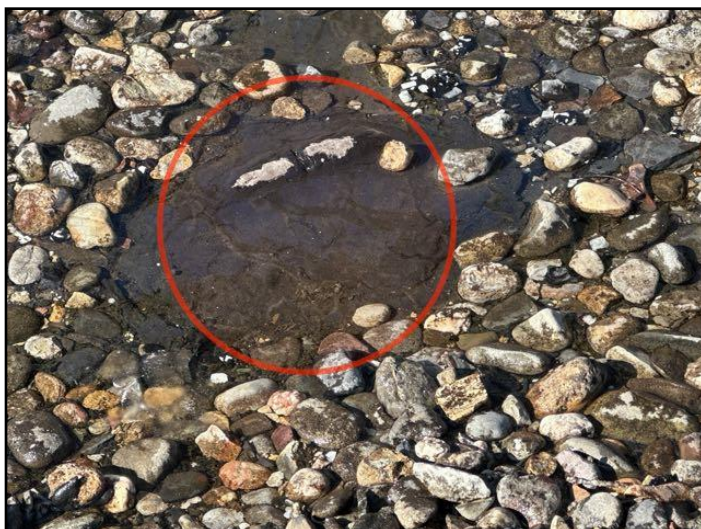
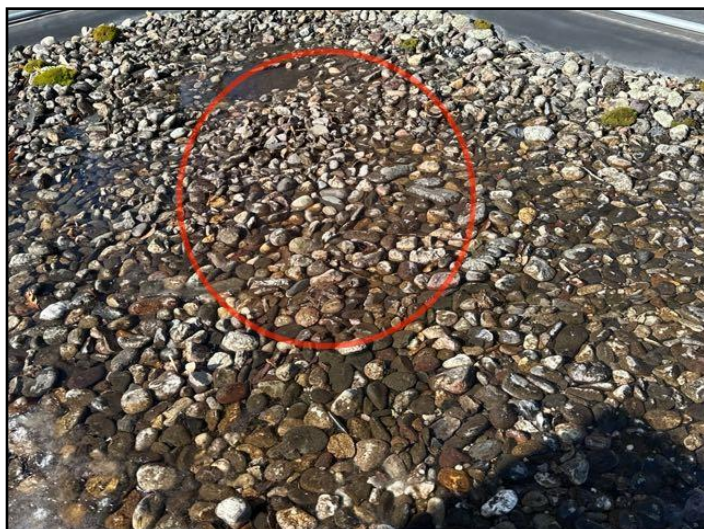
**2. Condition:** • Flat roof drainage needs to be improved

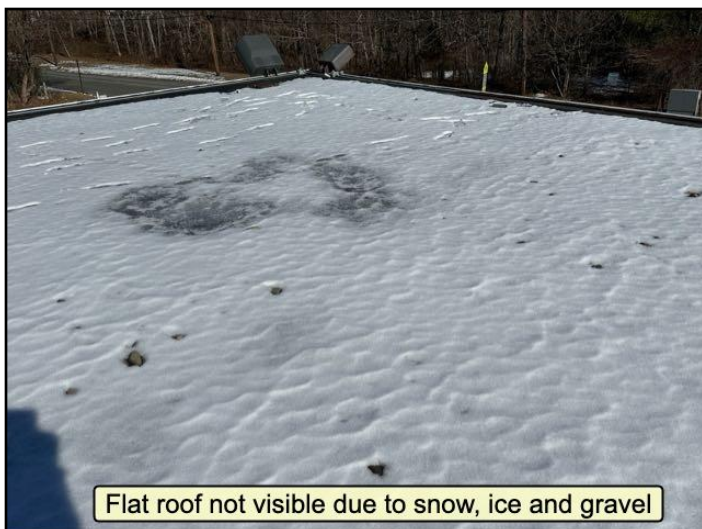
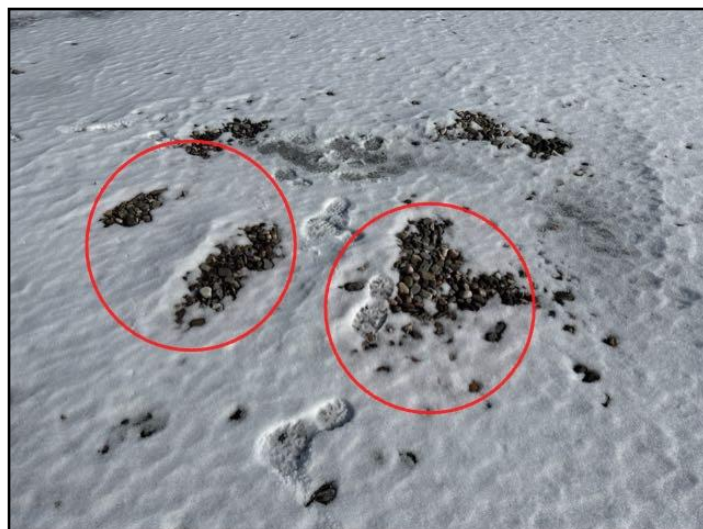
**3. Condition:** • Not visible

Flat roof not visible due to snow, ice and gravel

Not visible

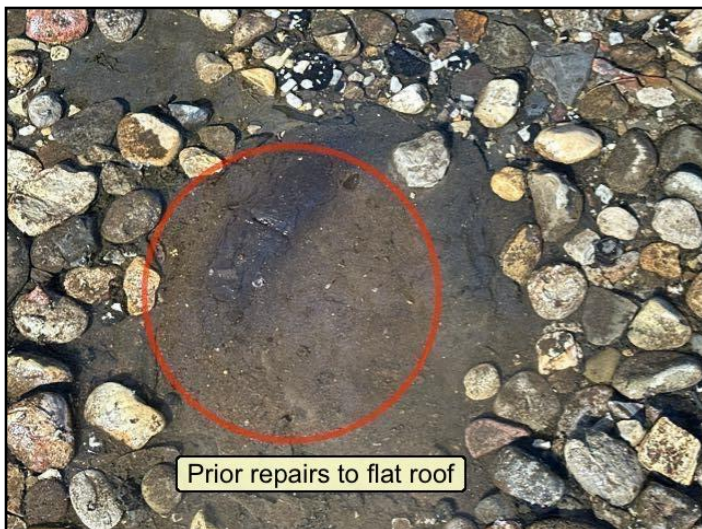
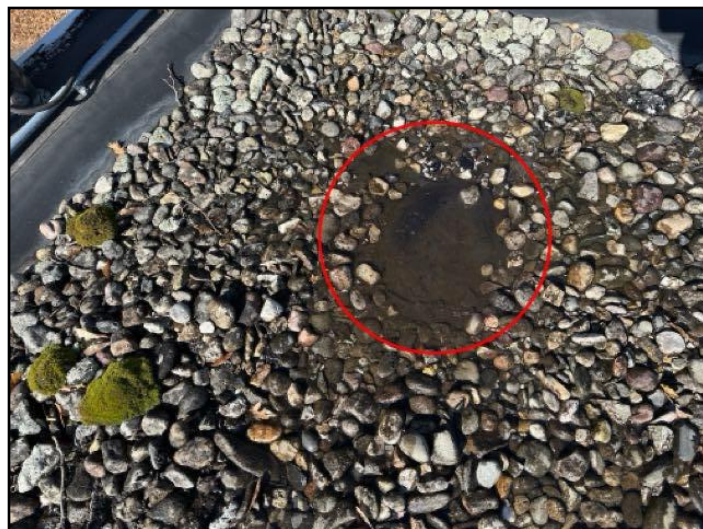
#### 4. Condition: • Prior repairs to flat roof

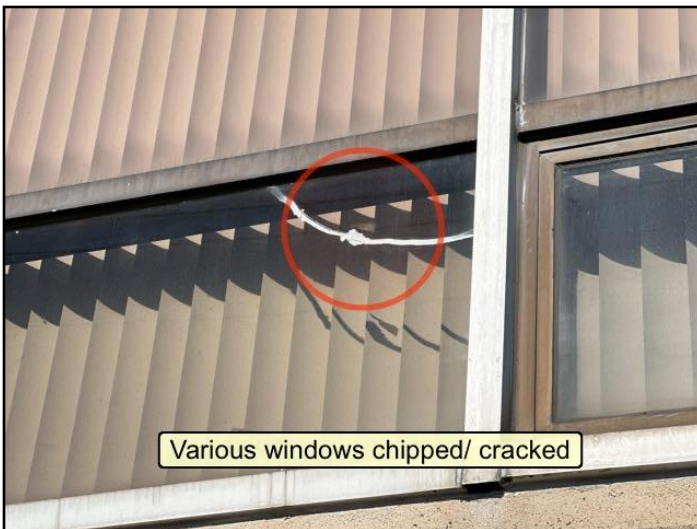
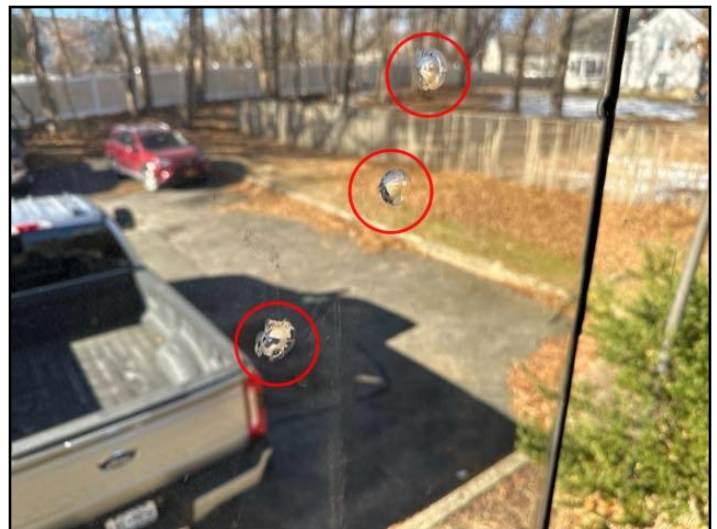
**7. Condition:** • [Cracked](#)

Various windows chipped/ cracked

Cracked

**Task:** Repair or replace

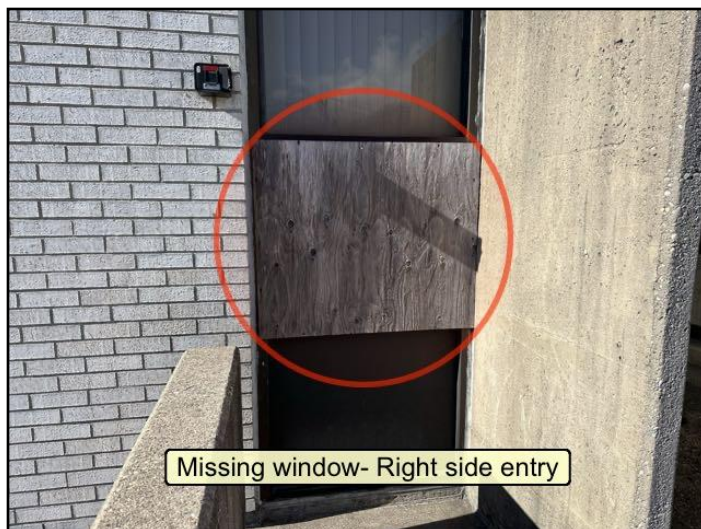
**8. Condition:** • [Missing](#)

Missing

**Task:** Repair

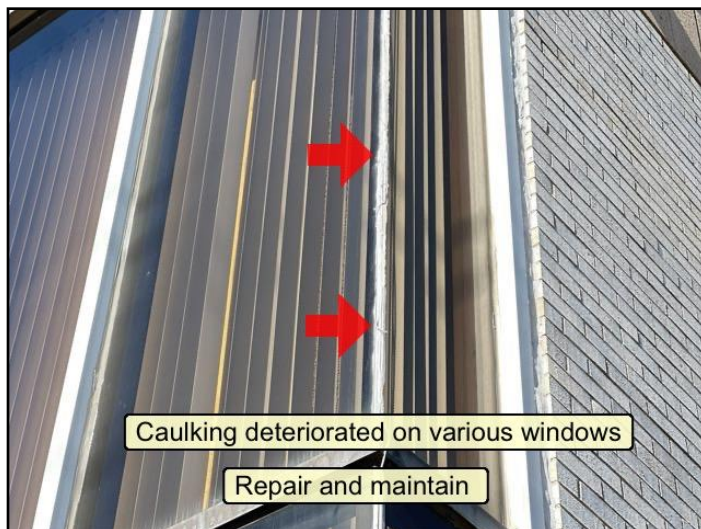
**9. Condition:** • Caulking deteriorated on various windows

Repair and maintain

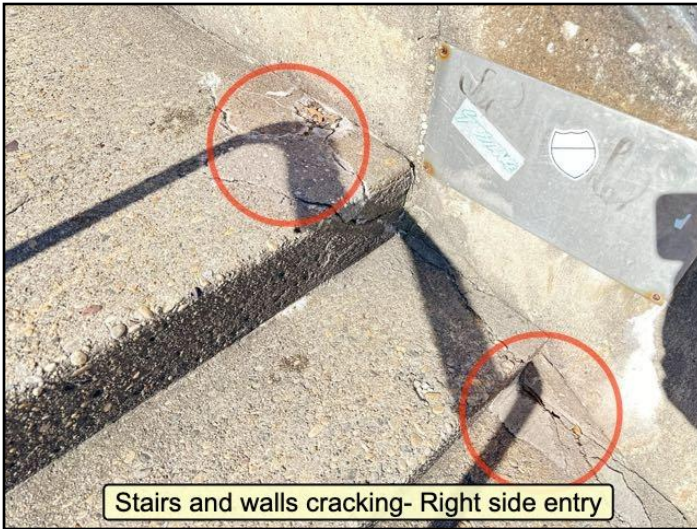
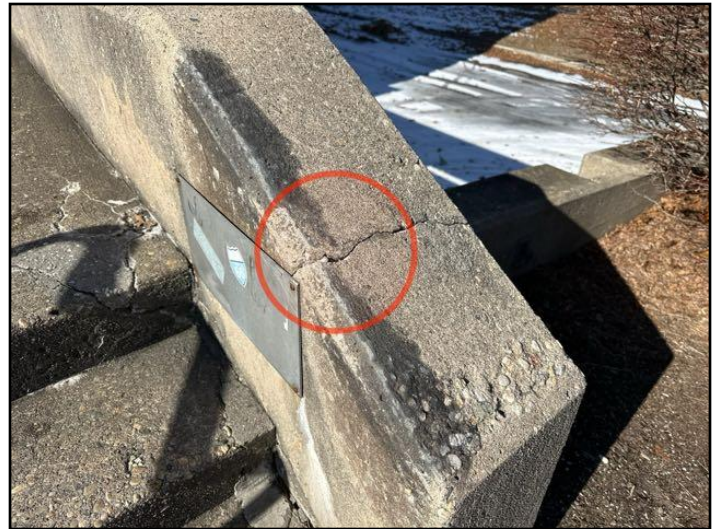
**10. Condition:** • [Masonry or concrete cracking](#)

Stairs and walls cracking- Right side entry

*Masonry or concrete cracking*

**Task:** Repair

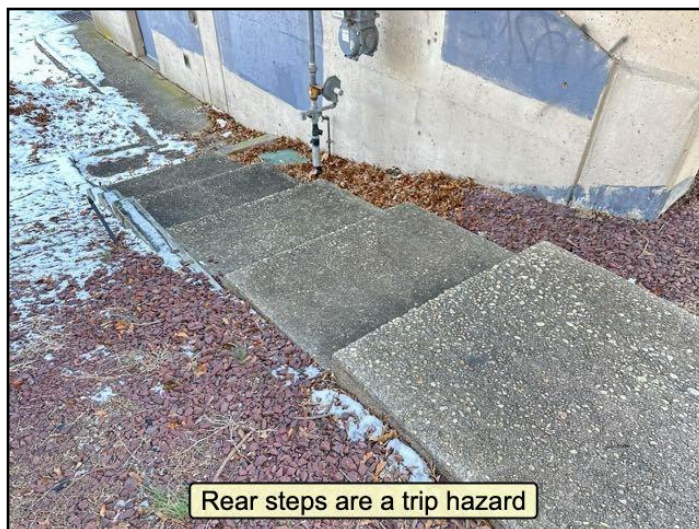
Rear steps are a trip hazard

*Trip hazard***PORCHES, DECKS, STAIRS, PATIOS \ \*Handrails and guards\*****12. Condition:** • [Missing](#)

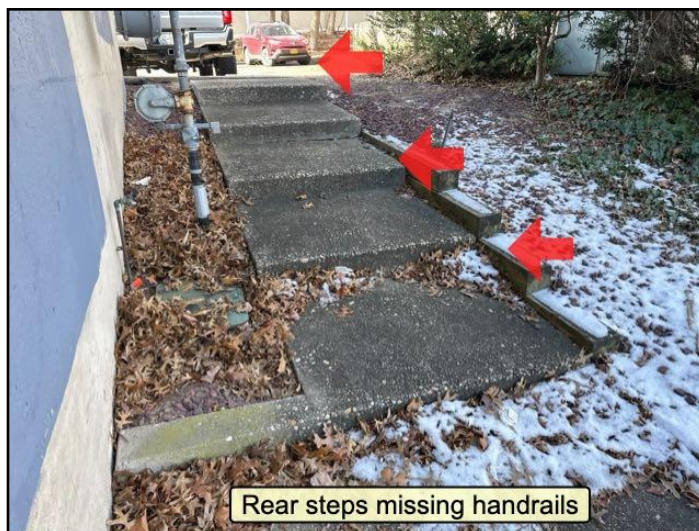
Rear steps missing handrails

*Missing***LANDSCAPING \ #General notes****13. Condition:** • Trees or shrubs too close to building

**Implication(s):** Fall hazard**Location:** Rear**Task:** Provide**Time:** As soon as practical

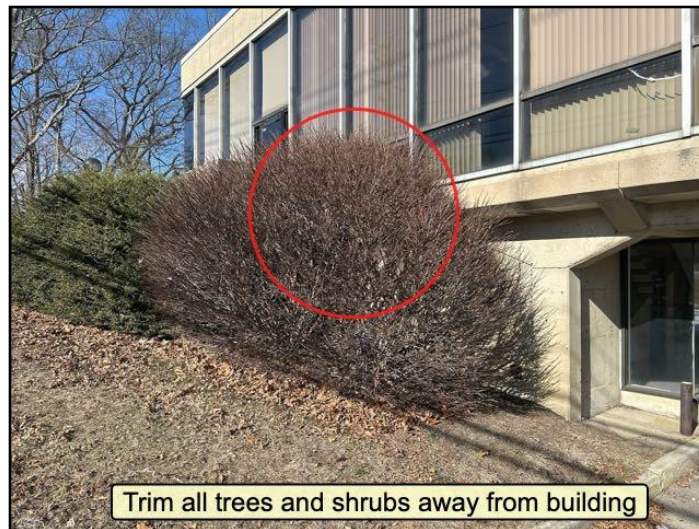
*Trees or shrubs too close to building*

Trim all trees and shrubs away from building

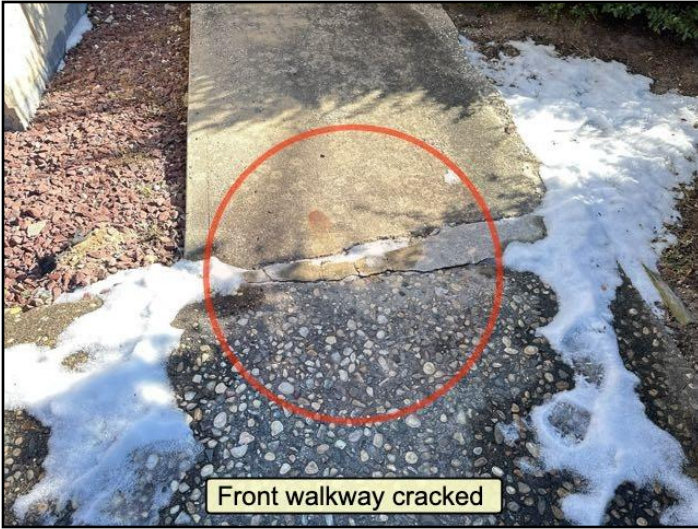
Front walkway cracked

Uneven (trip hazard)

**Task:** Repair

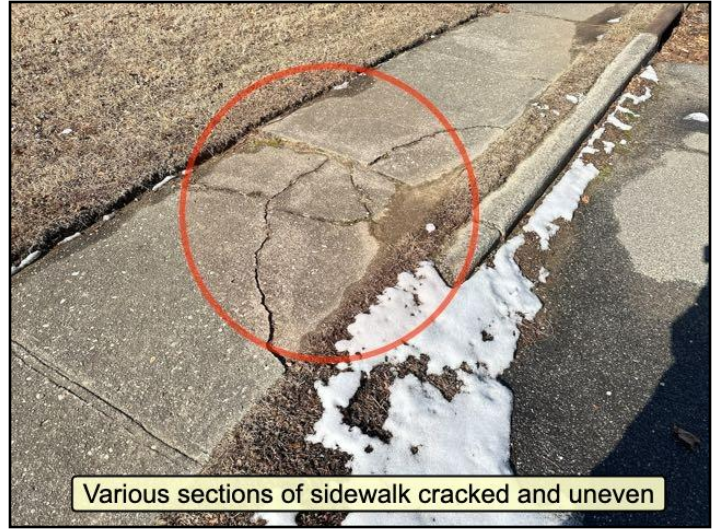
Various sections of sidewalk cracked and uneven

Uneven (trip hazard)

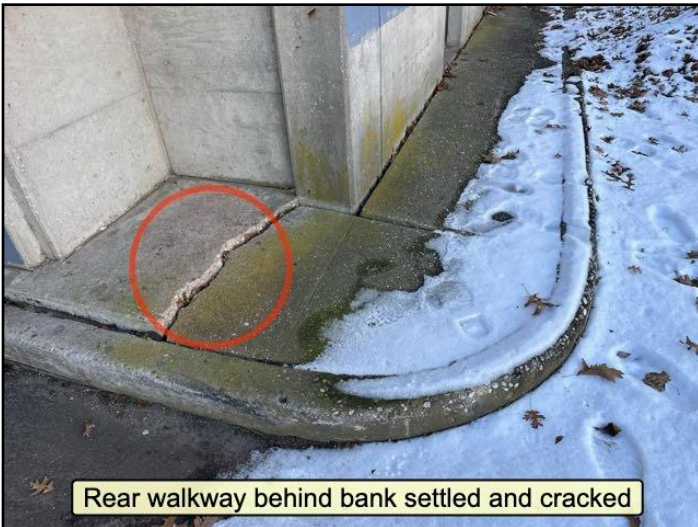
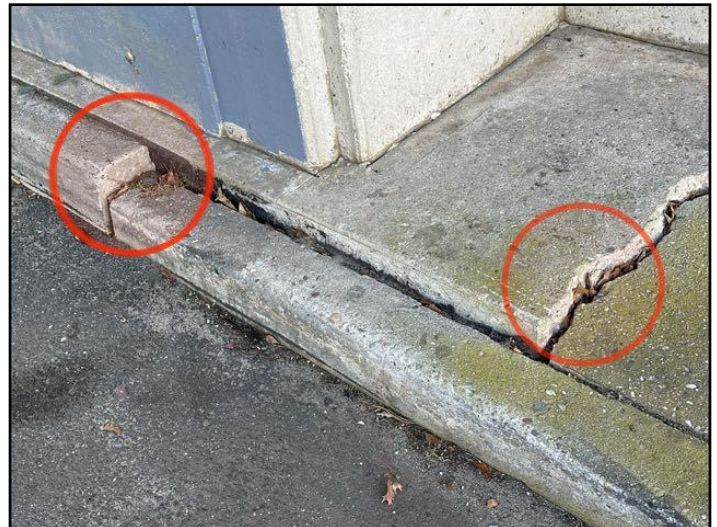
Rear walkway behind bank settled and cracked

Settlement

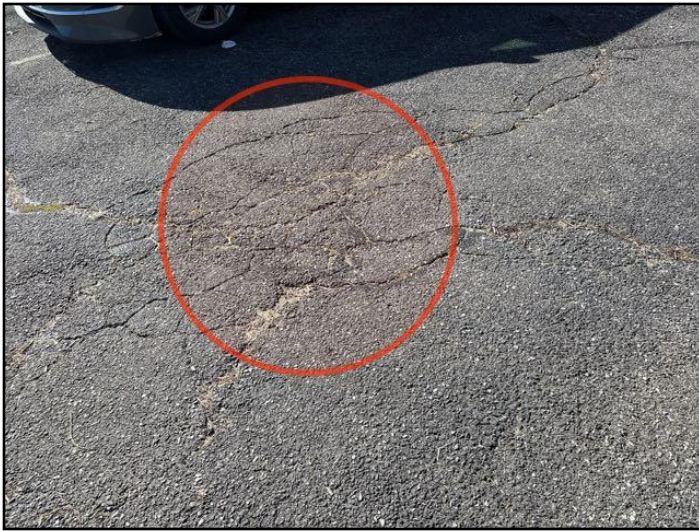
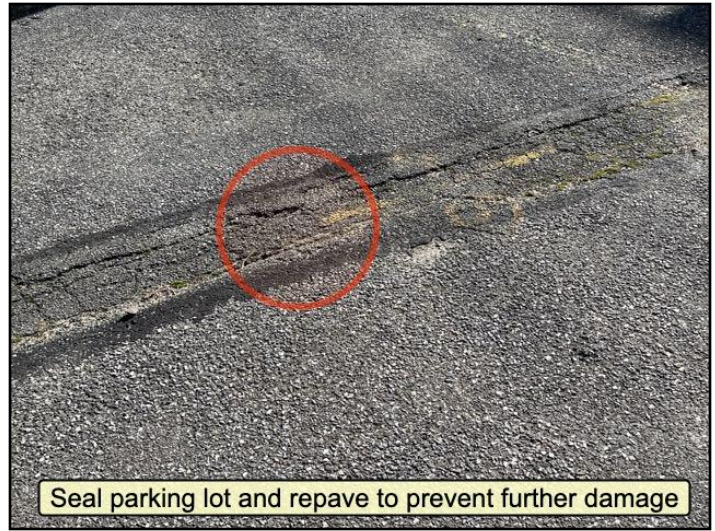
### 17. Condition: • [Cracked or damaged surfaces](#)

*Cracked or damaged surfaces*

*Cracked or damaged surfaces***18. Condition:** • [Improper slope or drainage](#)

Seal parking lot and repave to prevent further damage

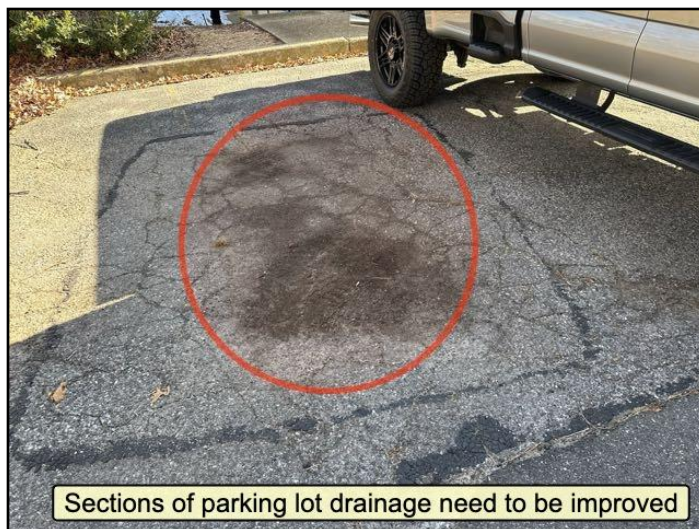
Sections of parking lot drainage need to be improved

*Improper slope or drainage*

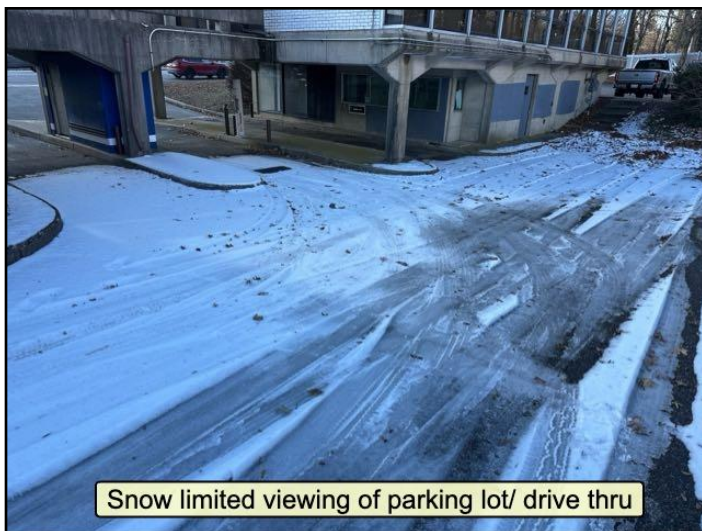
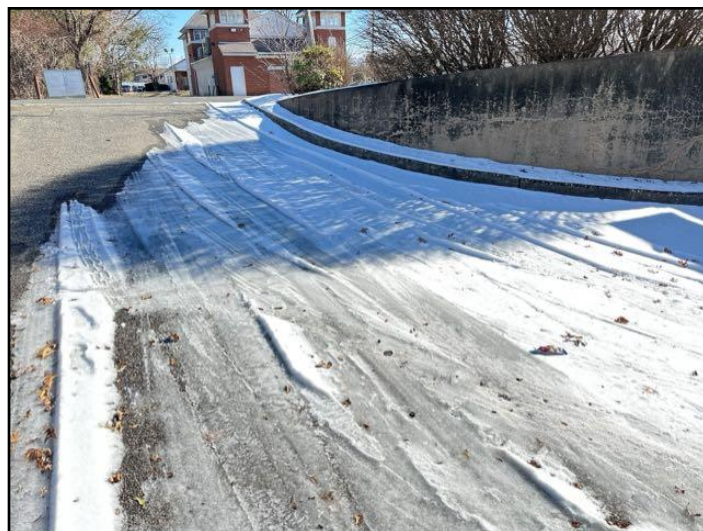
Snow limited viewing of parking lot/ drive thru

Snow / ice / frost

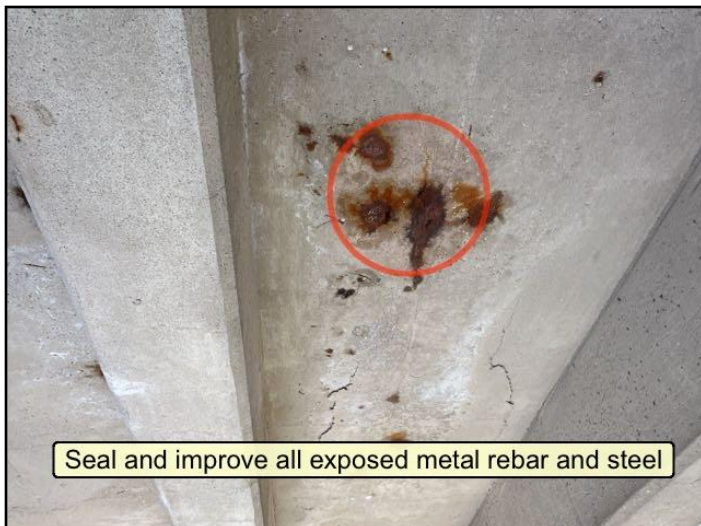
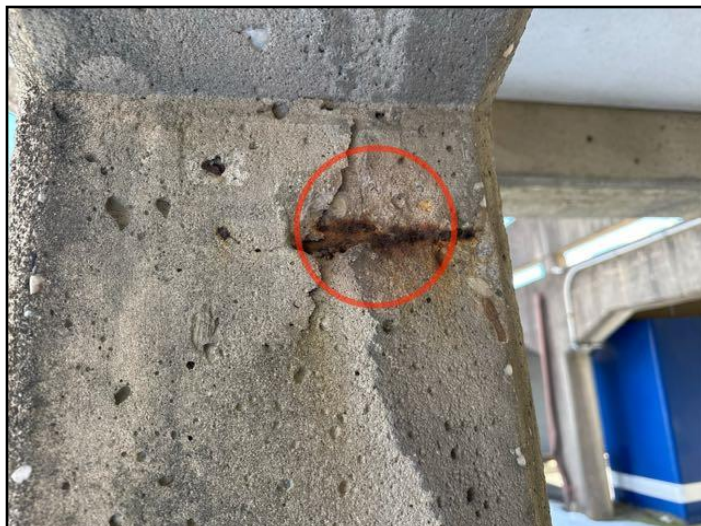
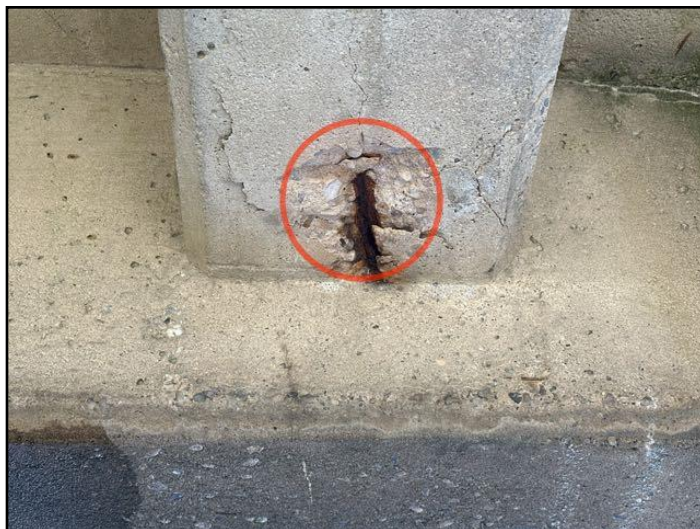
**21. Condition:** • Seal and improve all exposed metal rebar and steel

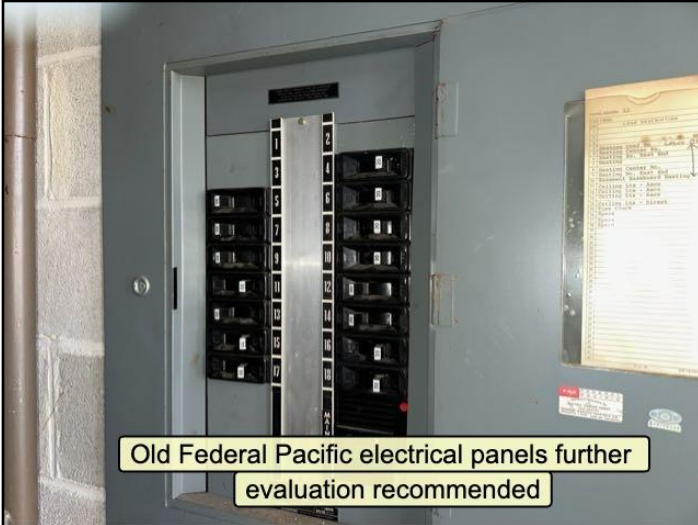
Old Federal Pacific electrical panels further evaluation recommended

Have licensed electrician further evaluate panels

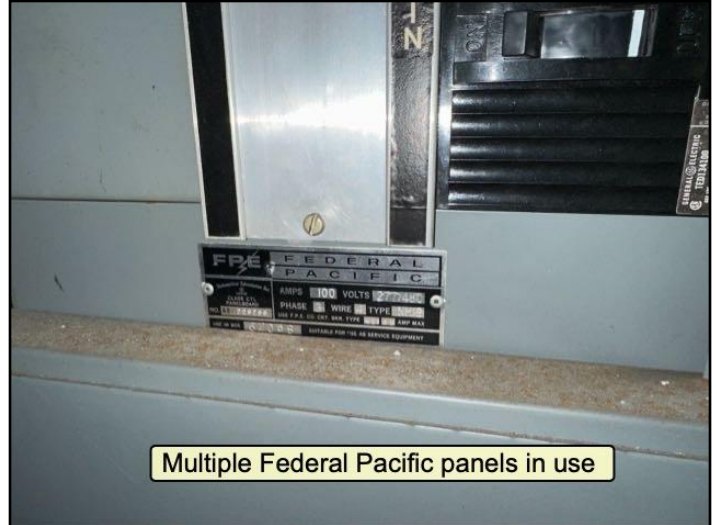
Multiple Federal Pacific panels in use

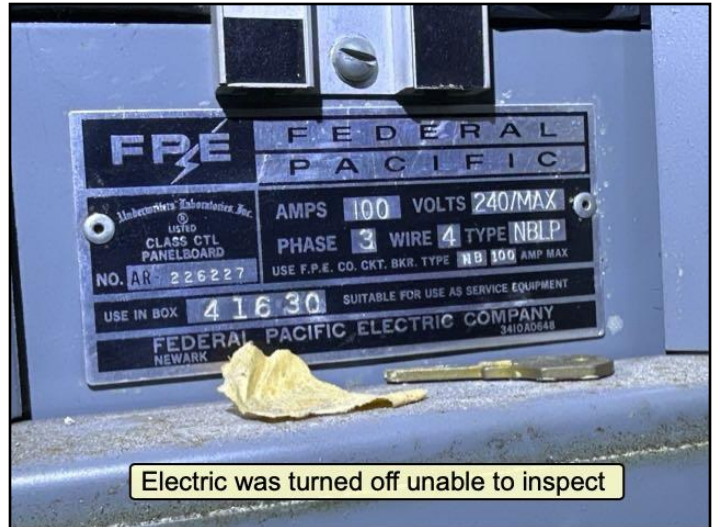
Electric was turned off unable to inspect

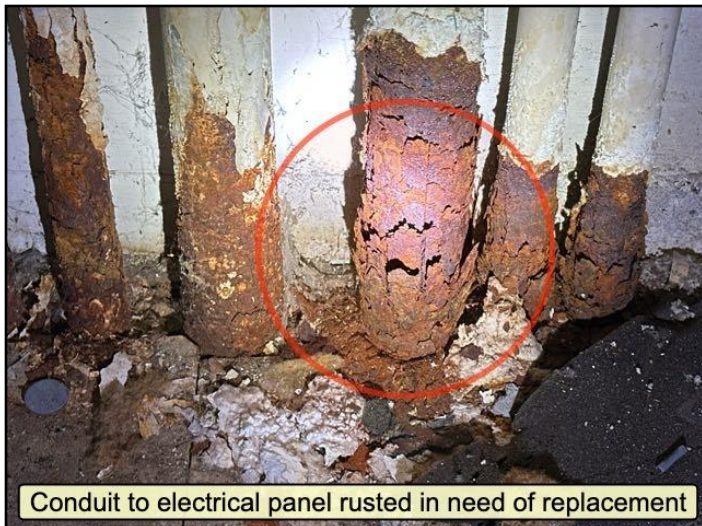
Conduit to electrical panel rusted in need of replacement

*damaged / rusted conduit*

**Task:** Replace

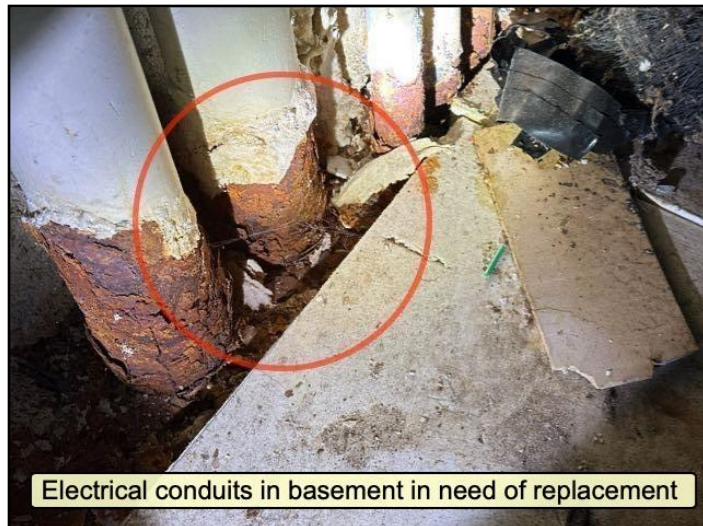
Electrical conduits in basement in need of replacement

*damaged / rusted conduit*

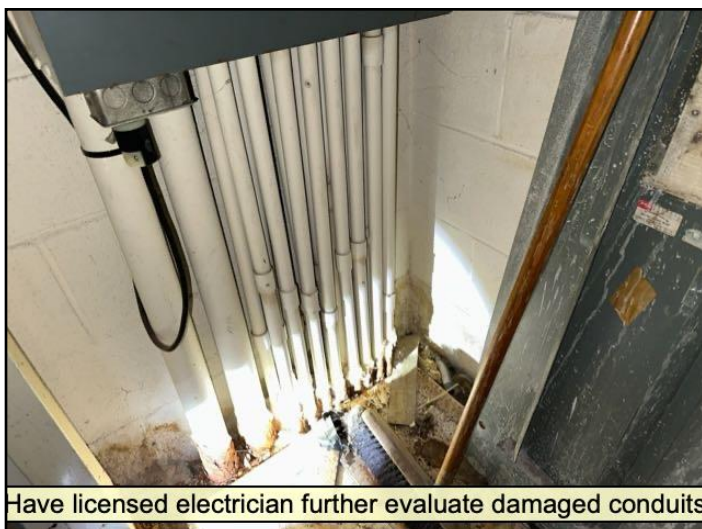
*damaged / rusted conduit*

Have licensed electrician further evaluate damaged conduits

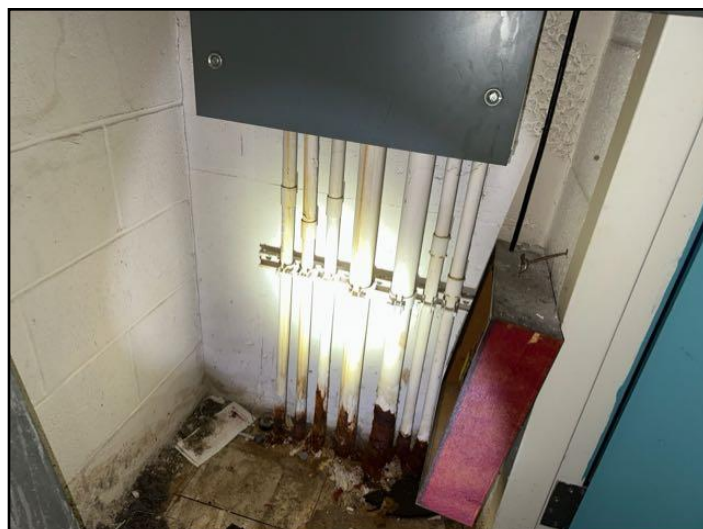
*damaged / rusted conduit***COMMENTS \ Additional**

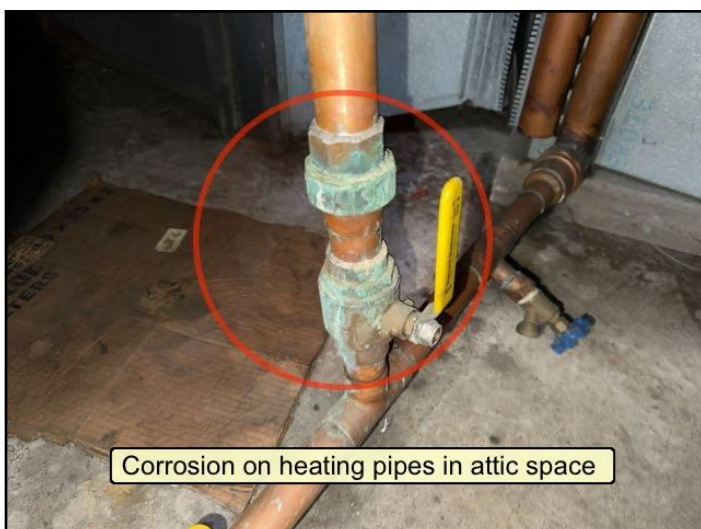
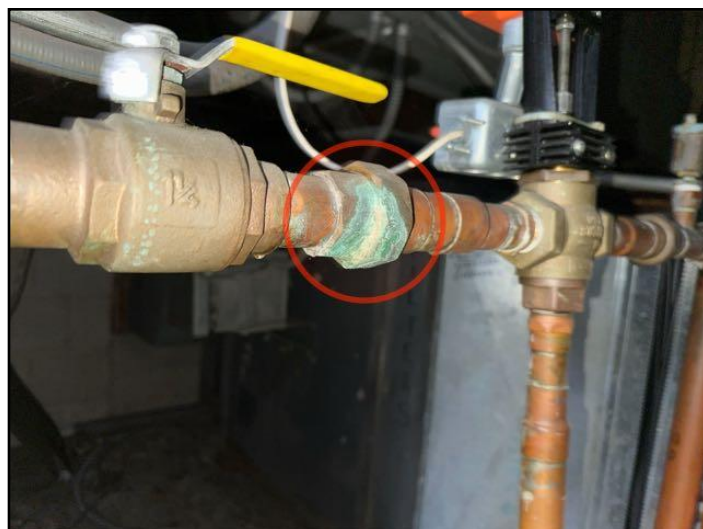
**26. Condition:** • Corrosion on heating pipes in attic space

**Task:** Repair or replace

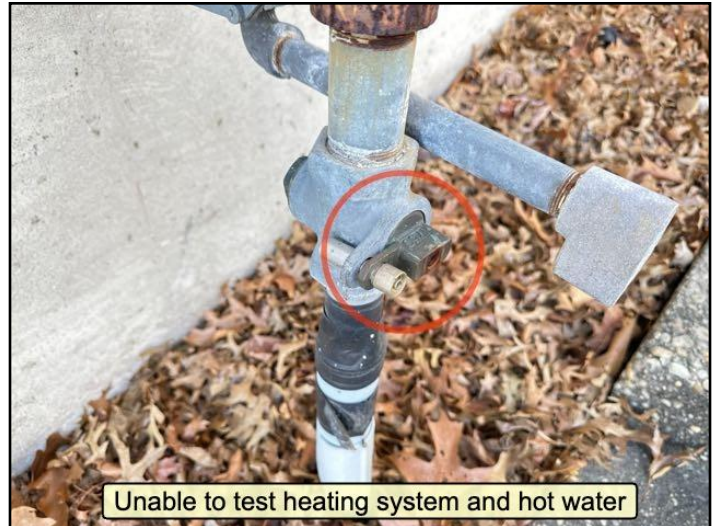
Gas was shut off at time of inspection

Unable to test heating system and hot water

Gas was shut off at time when inspection.

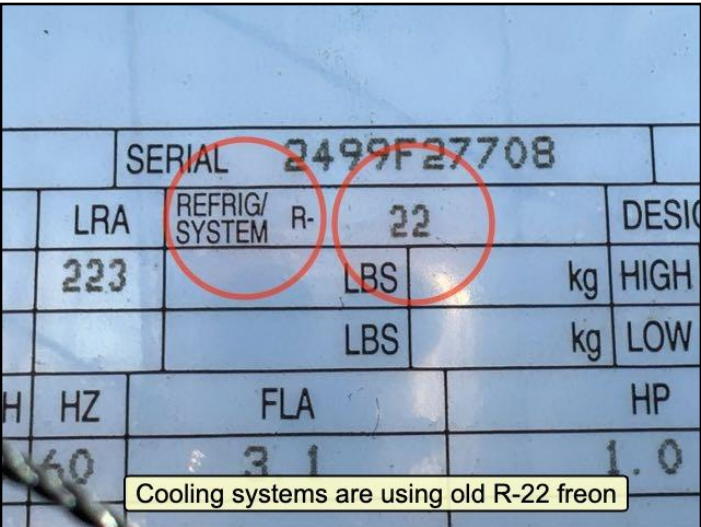
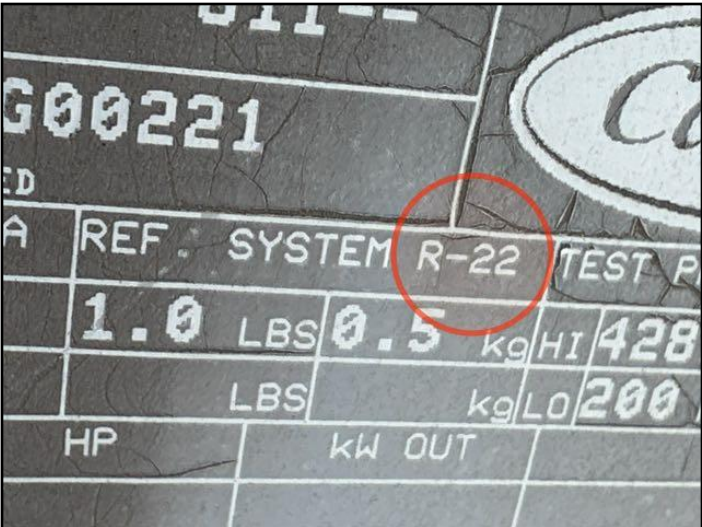
**29. Condition:** • AC is old using R-22 freon in system. This freon will not be available in the near future and is very expensive. Budget for replacement of AC unit when needed.  
Cooling systems are using old R-22 freon  
**Task:** Budget for replacement

AC is old using R-22 freon in system. This...

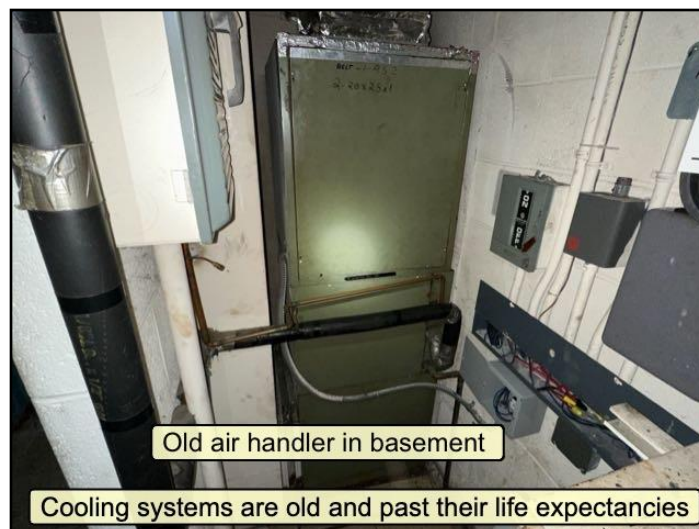
Cooling systems are old and past their life expectancies

*Past life expectancy*

Recommend further evaluation by a licensed HVAC technician for repair and replacement quotes

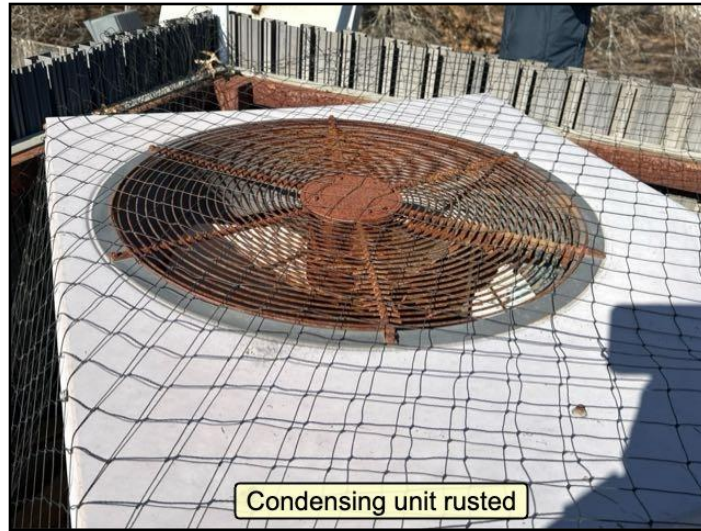
Condensing unit rusted

*Rust*

**Task:** Replace

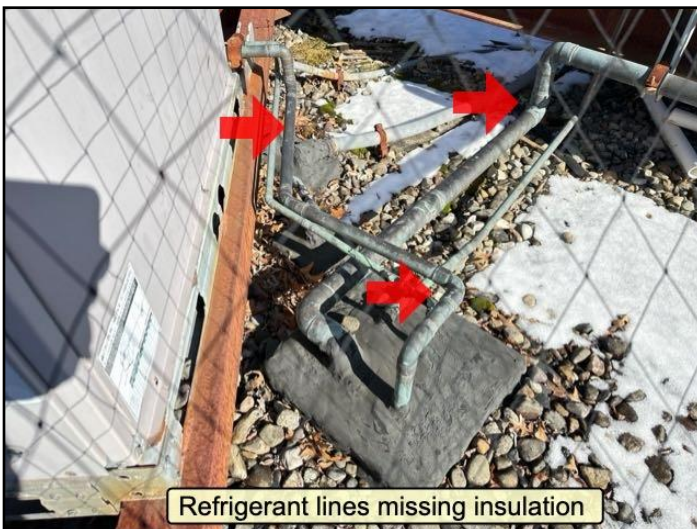
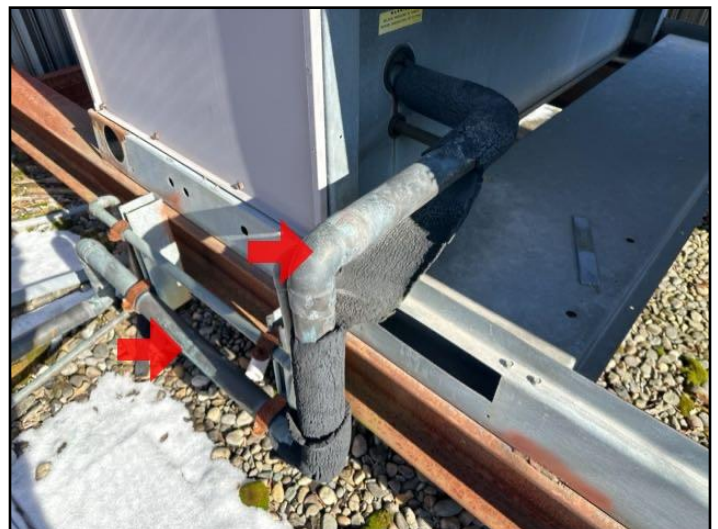
### 33. Condition: • Insulation - missing

The larger low pressure suction line requires insulation to protect it from condensation. Without insulation around this line, thermal energy is lost and condensation forms, which can both lower efficiency and cause moisture damage to the unit.

*Insulation - missing*

**Task:** Improve

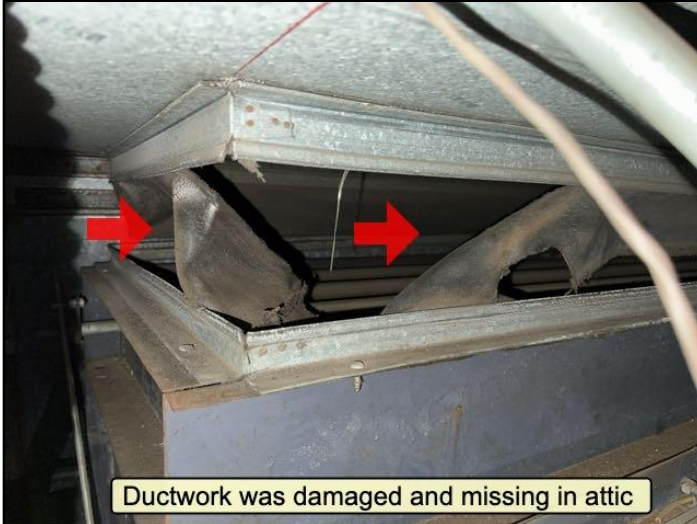
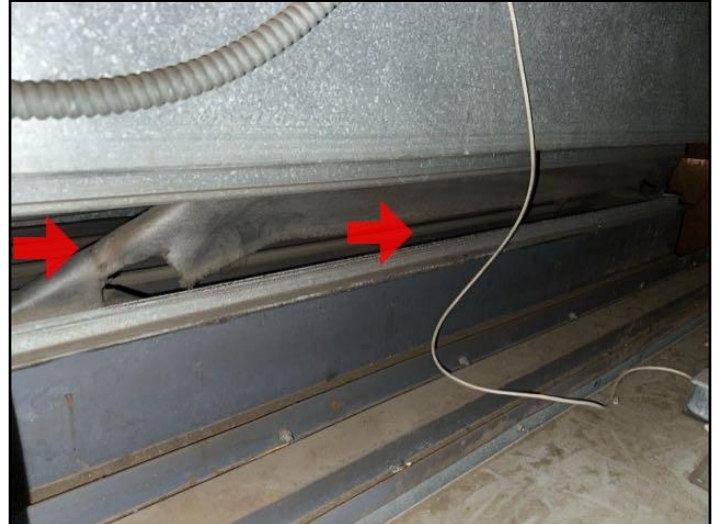
Ductwork was damaged and missing in attic

*Disconnected or leaking*

**Task:** Replace

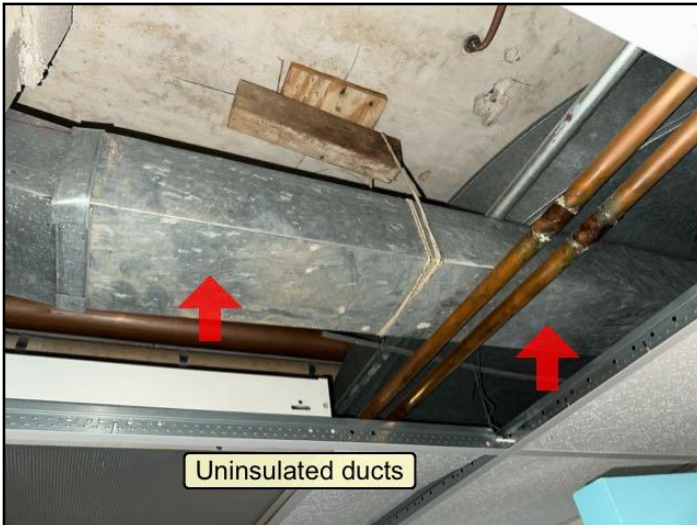
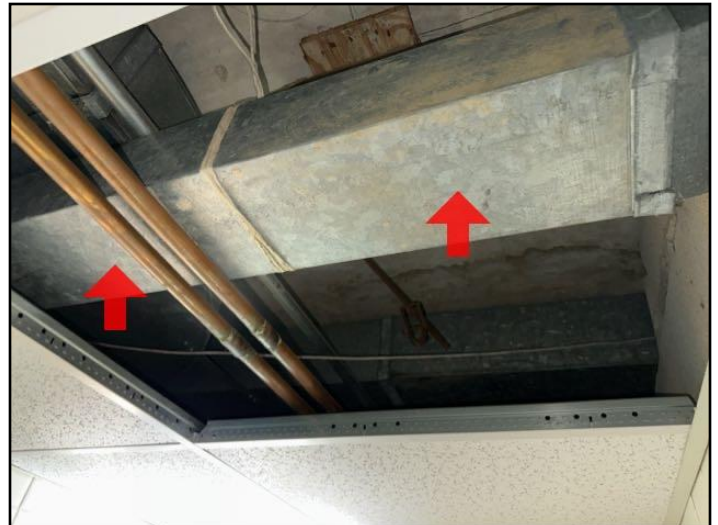
**35. Condition:** • Older uninsulated ducts

*Older uninsulated ducts*

**Task:** Improve

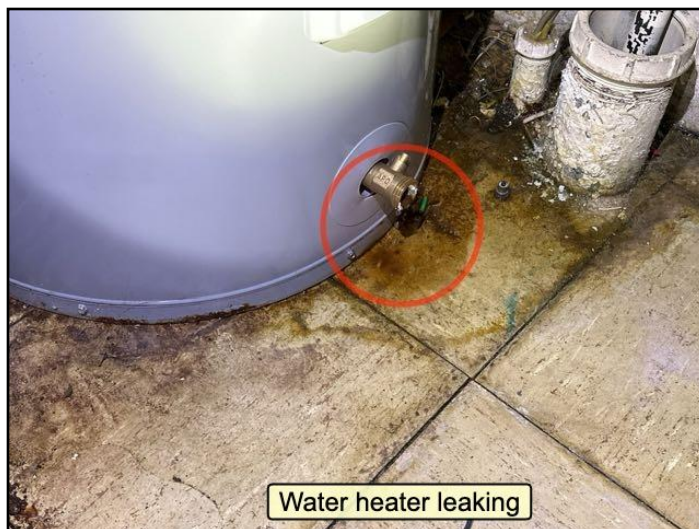
Water heater leaking

*Leak***Inspection Method and Limitations****Inspection limited/prevented by:**

**Implication(s):** Chance of water damage to structure, finishes and contents**Location:** Basement**Task:** Repair or replace

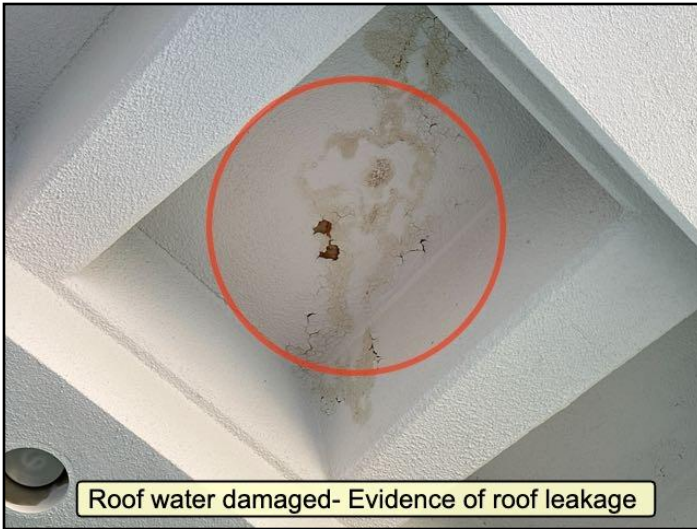
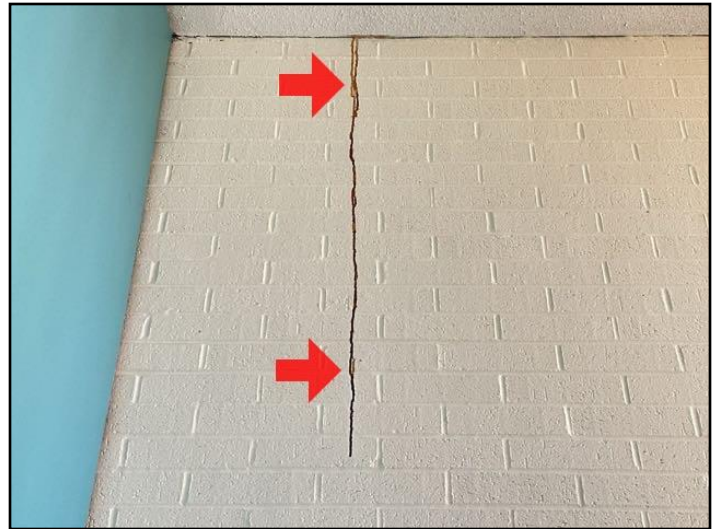
Roof water damaged- Evidence of roof leakage

Water damage

**Task:** Repair/ replace roof

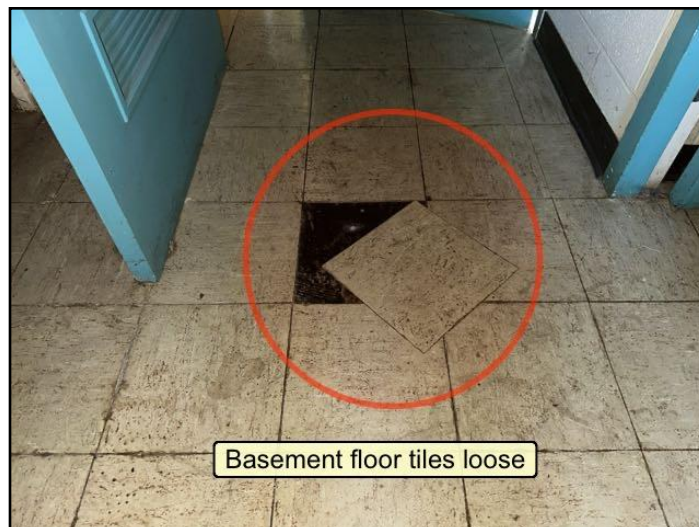
**40. Condition:** • Basement floor tiles loose

**Task:** Repair or replace

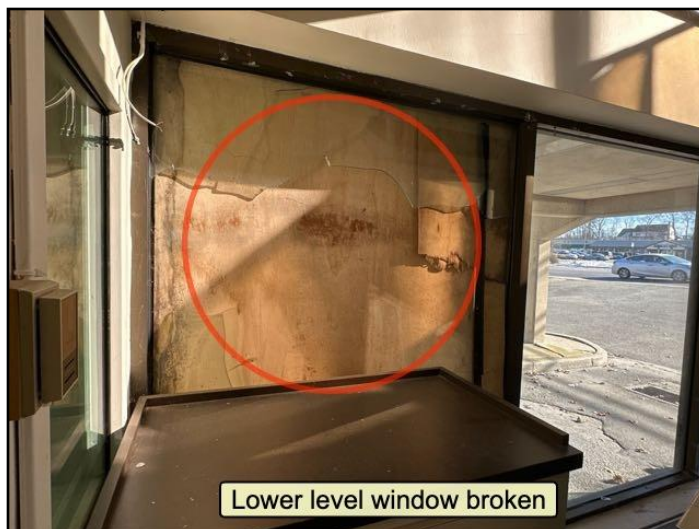
Lower level window broken

*Broken***POTENTIALLY HAZARDOUS MATERIALS \ General notes****42. Condition:** • Possible asbestos containing materials

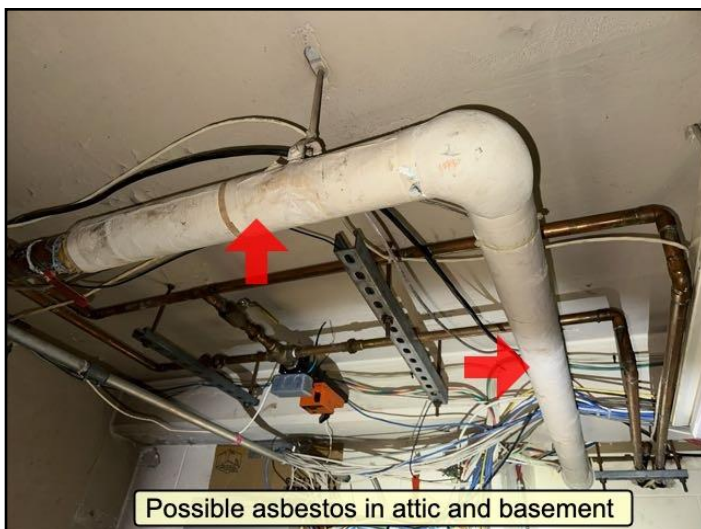
Asbestos is a fibrous material that was used in many building materials as a fire resistant material, a binder, and a thermal insulator. The very small asbestos fibers can cause cancer and other types of lung disease if inhaled. Demolition or renovation work can disturb asbestos-containing materials, causing the asbestos fibers to be released into the air. Various heating pipes have possible asbestos contain material. Corrective actions related to asbestos should not be undertaken by the property owner, as a general rule. Recommend further evaluation by a licensed environmental specialist company to provide cost of removal.

*Possible asbestos containing materials*
