INSPECTION REPORT

For the Property at:
123 MAIN ST
NEW YORK, NY 10023

Prepared for: JOHN SMITH
Inspection Date: Monday, December 15, 2025
Prepared by: Robert Byrne, License# 16000062890

RE: Report No. 2985, v.4
123 main st
New York, NY
10023

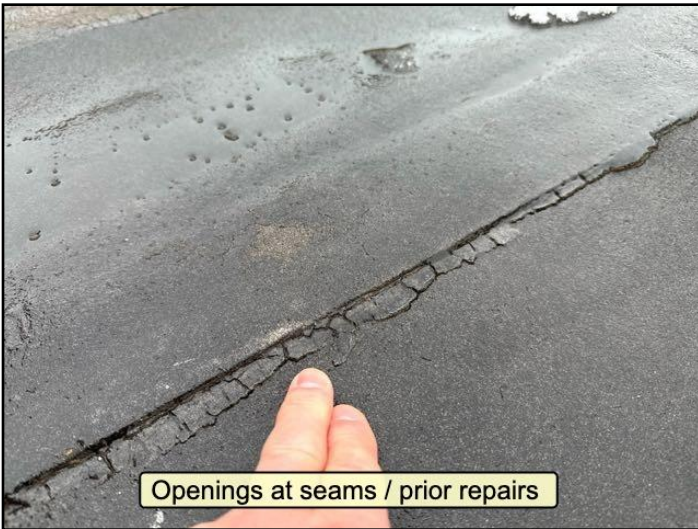
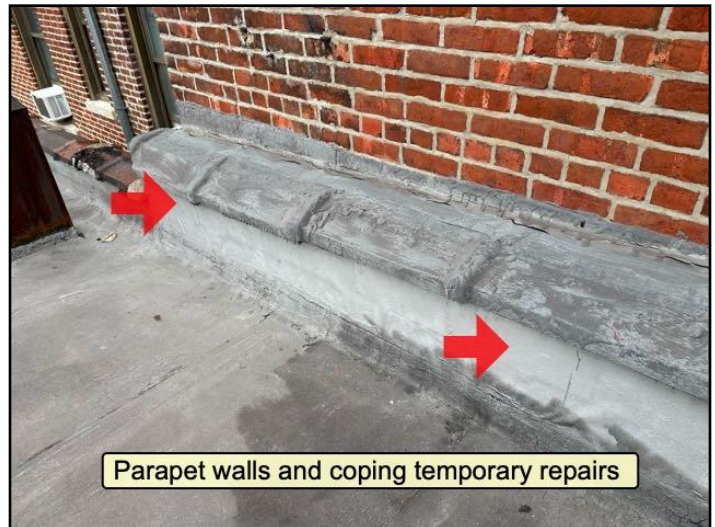
2. Condition: • [Openings at seams or flashings](#)

Recommend replacing roofing material and properly flashing various areas of concern on the roof. Repair attempts on roof are not done professionally and are a major concern for future leaks.

Implication(s): Chance of water damage to structure, finishes and contents

Openings at seams or flashings

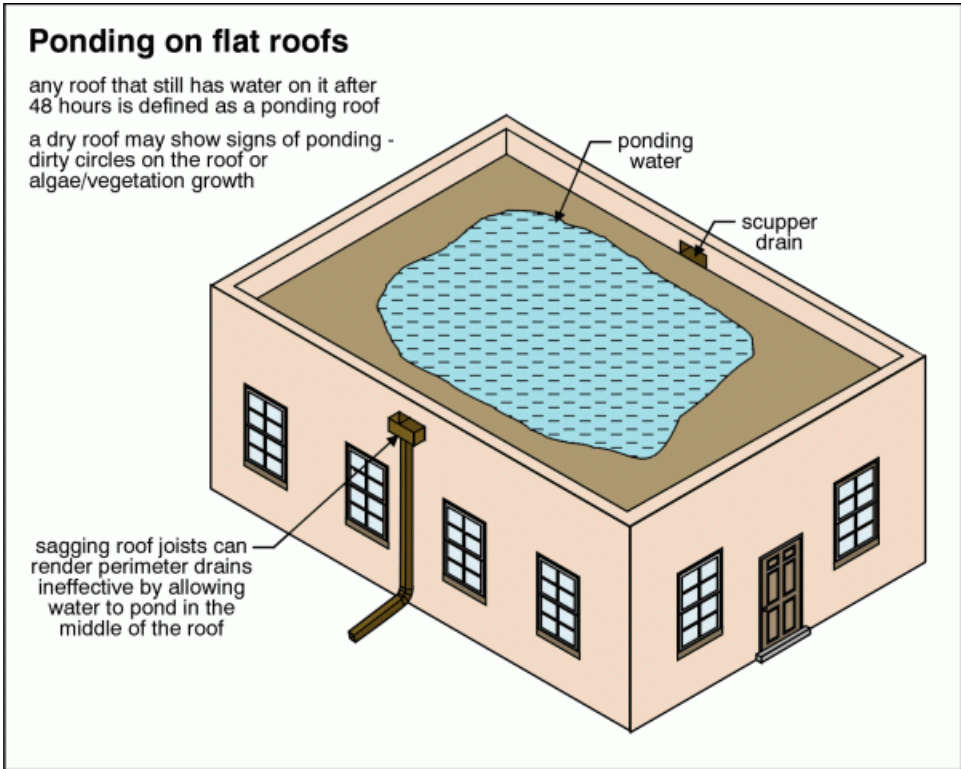
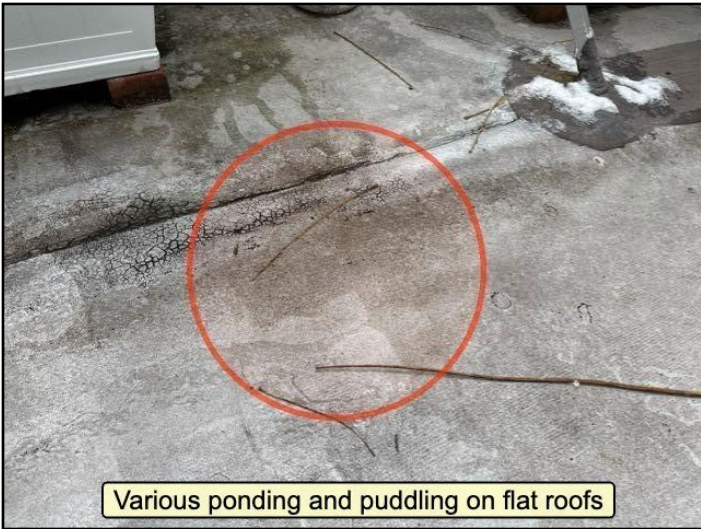
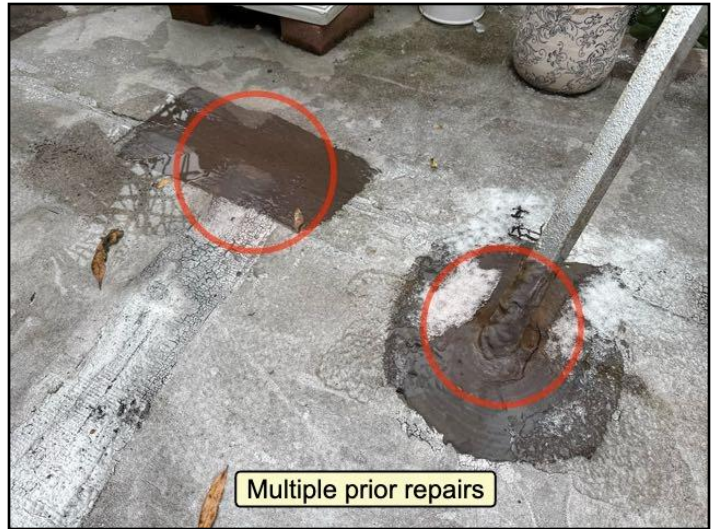
3. Condition: • [Ponding](#)

Implication(s): Chance of water damage to structure, finishes and contents

Ponding

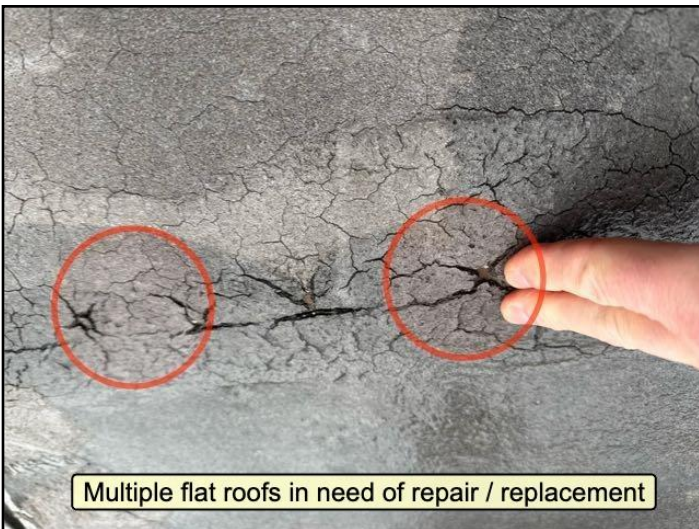
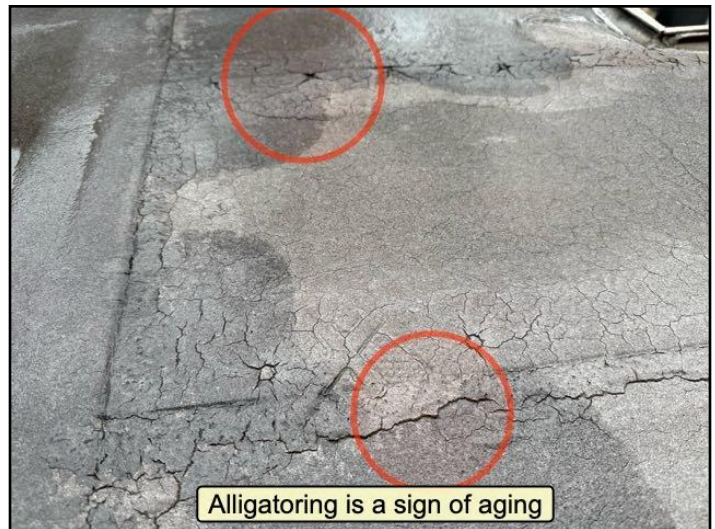
5. Condition: • Alligating

Alligating

Task: Improve / replace

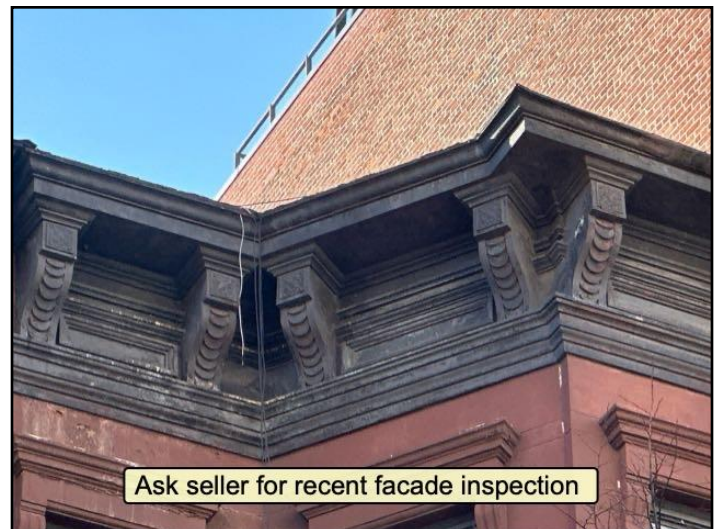
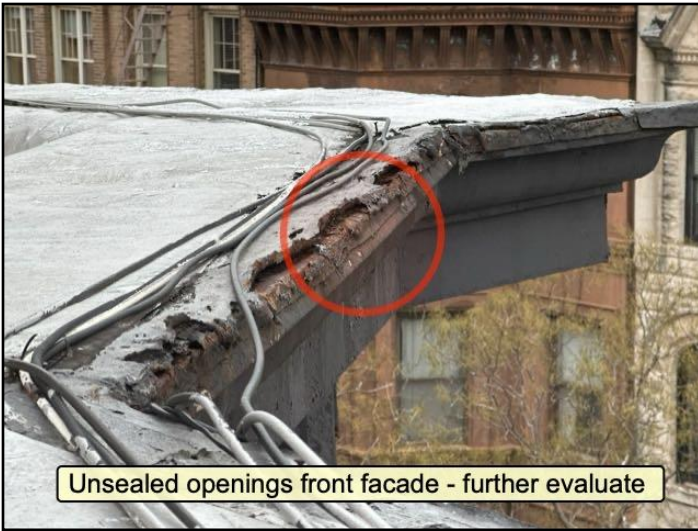
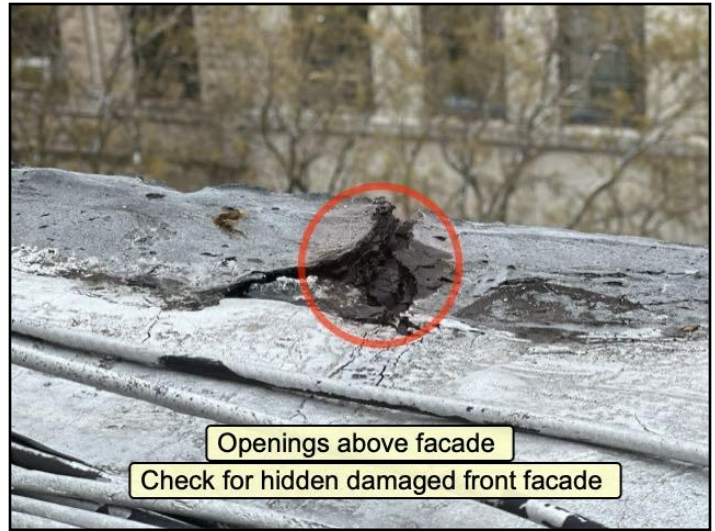
9. Condition: • General

Ask seller for recent facade inspection

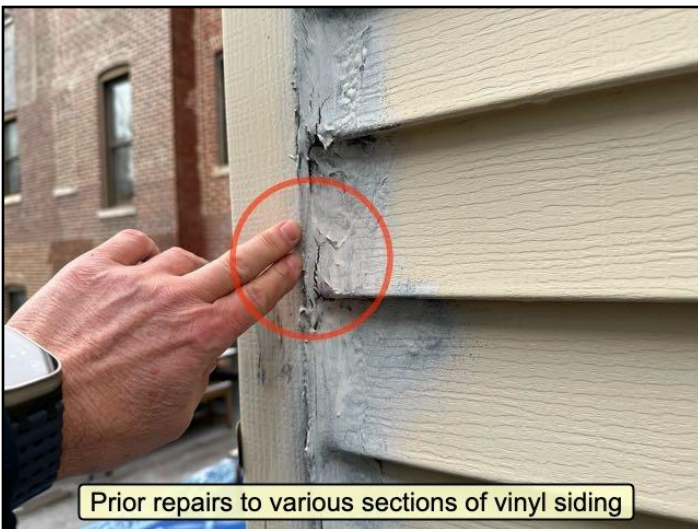
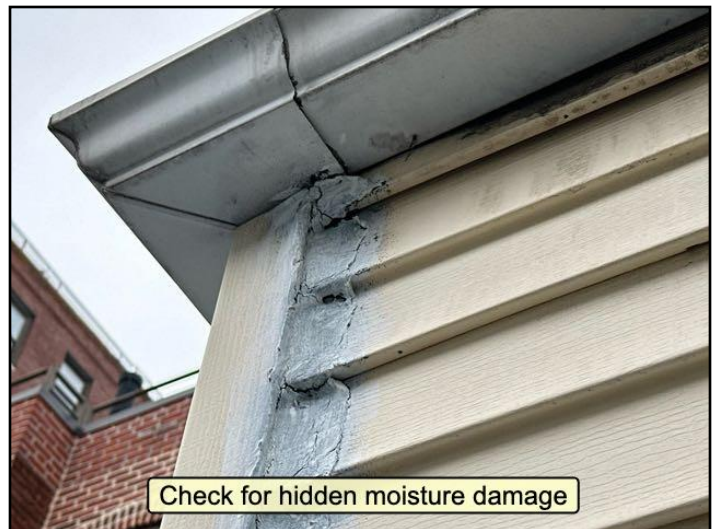
12. Condition: • Prior repairs

Prior repairs

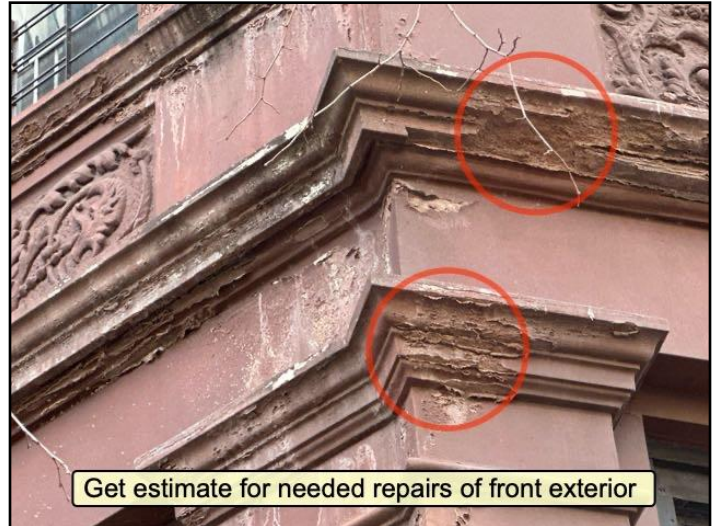
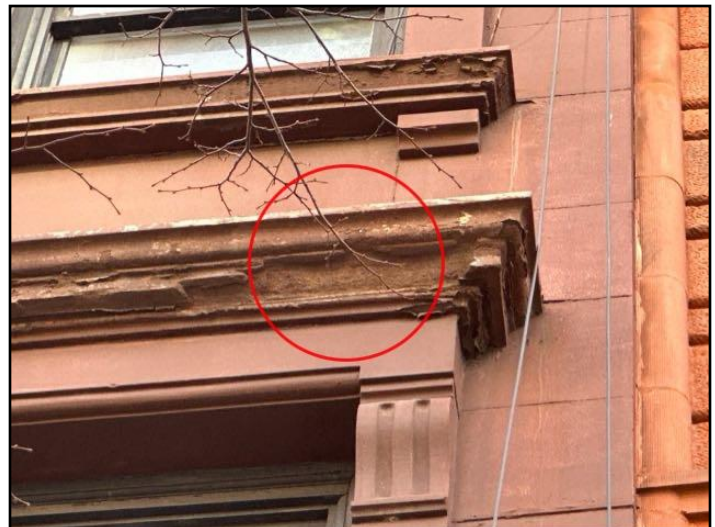
13. Condition: • [Masonry deterioration](#)

Masonry deterioration

****RECOMMEND GETTING ESTIMATE FOR ALL NEEDED EXTERIOR REPAIRS****

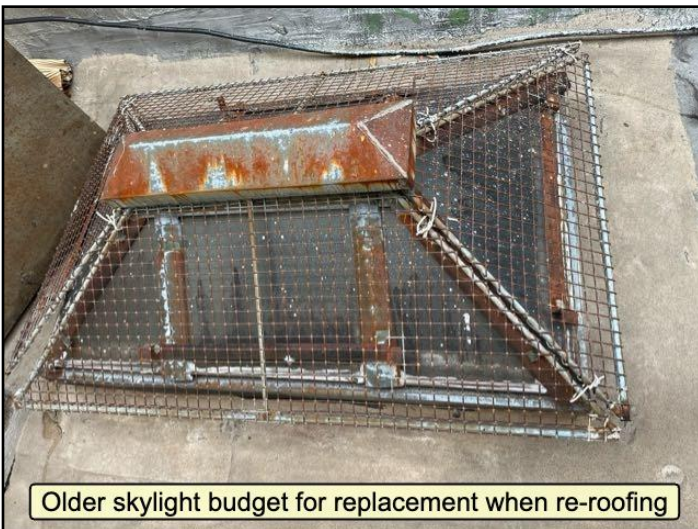
15. Condition: • Old

Old

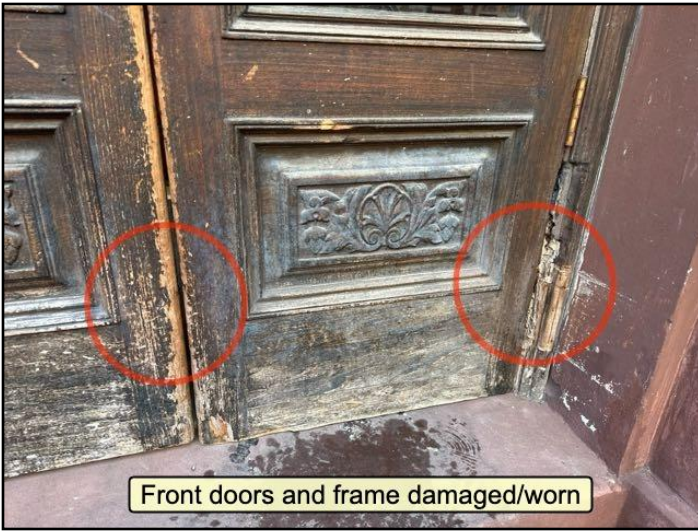
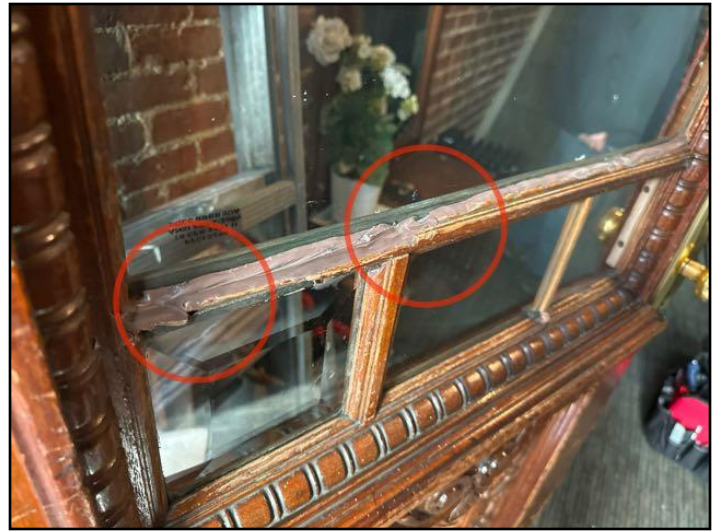
16. Condition: • [Damage](#)

Implication(s): Chance of damage to finishes and structure | Poor security

Damage

Task: Repair

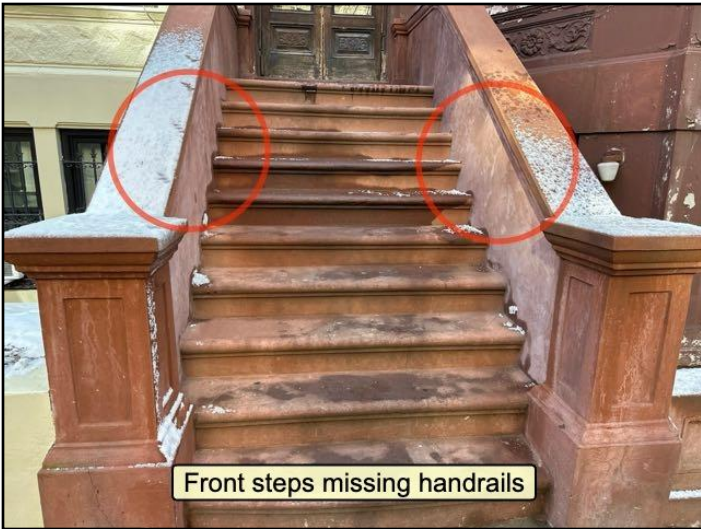
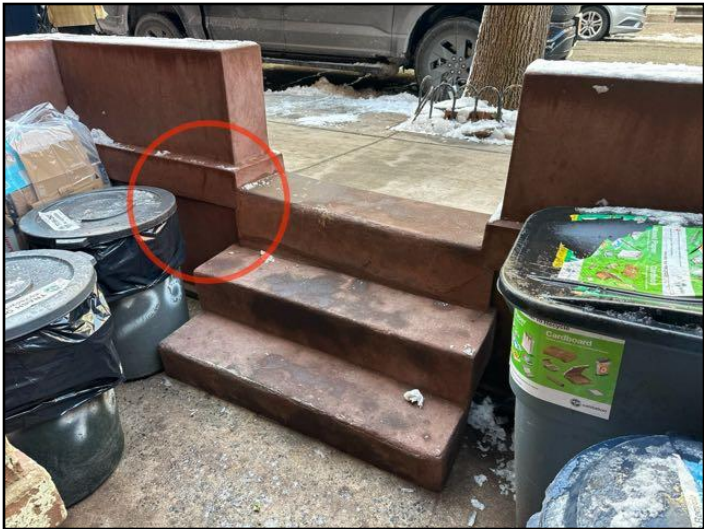
18. Condition: • [Missing](#)
Implication(s): Fall hazard
Location: Front
Task: Provide
Time: As soon as practical

Missing

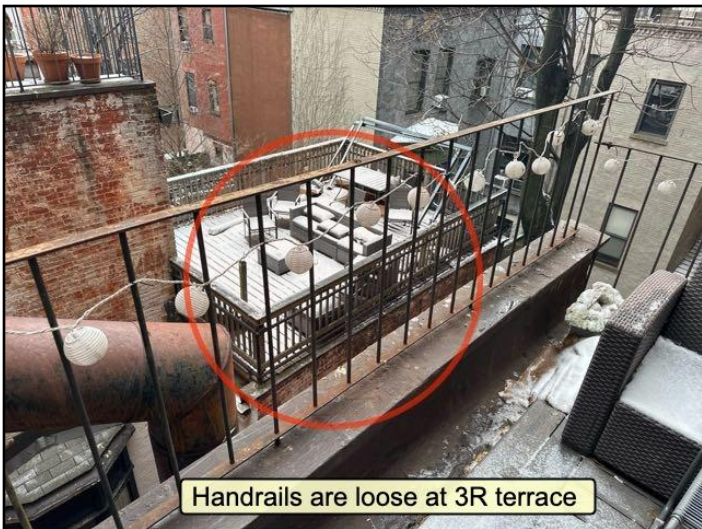
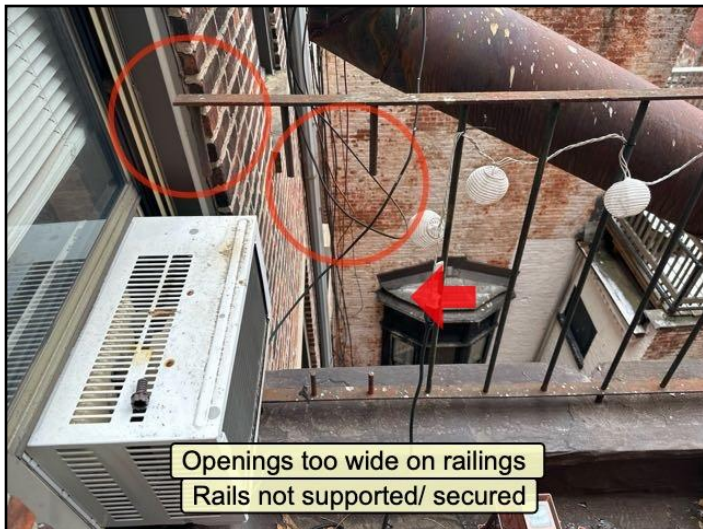
19. Condition: • [Loose](#)
Implication(s): Fall hazard
Location: 3R terrace
Task: Repair or replace
Time: As soon as practical

Loose

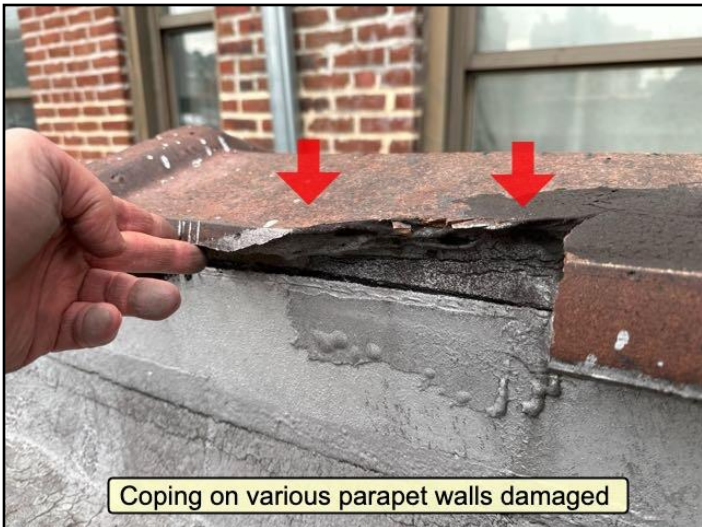
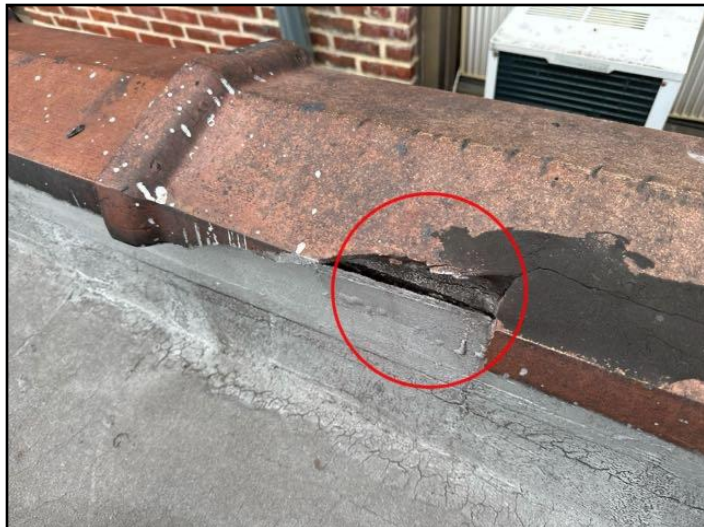
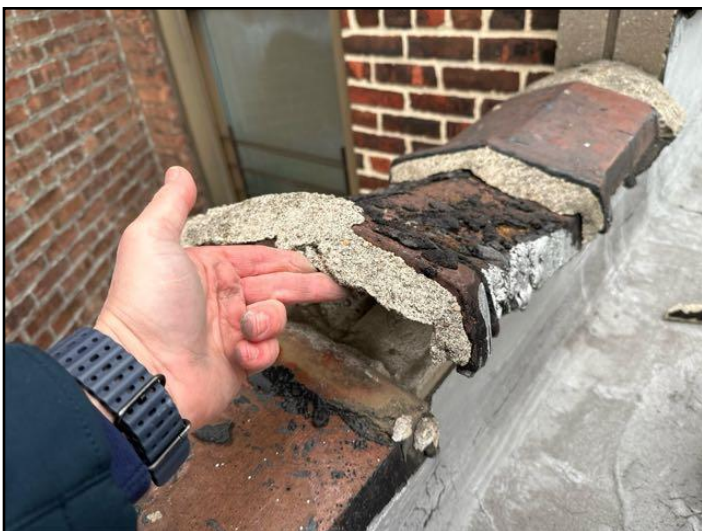
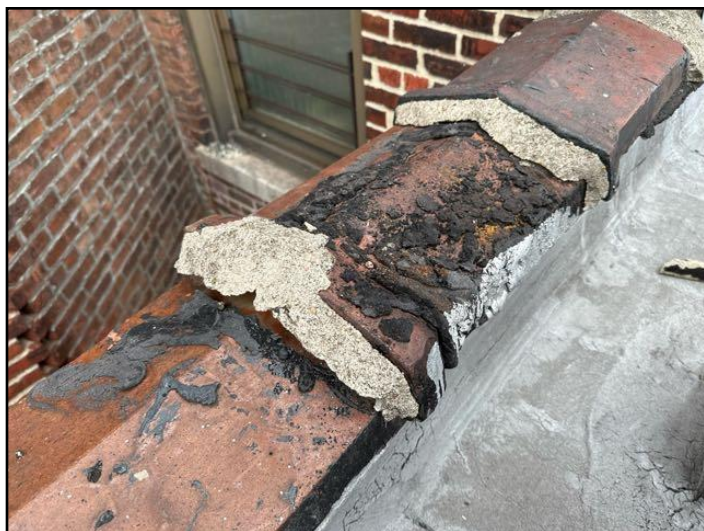
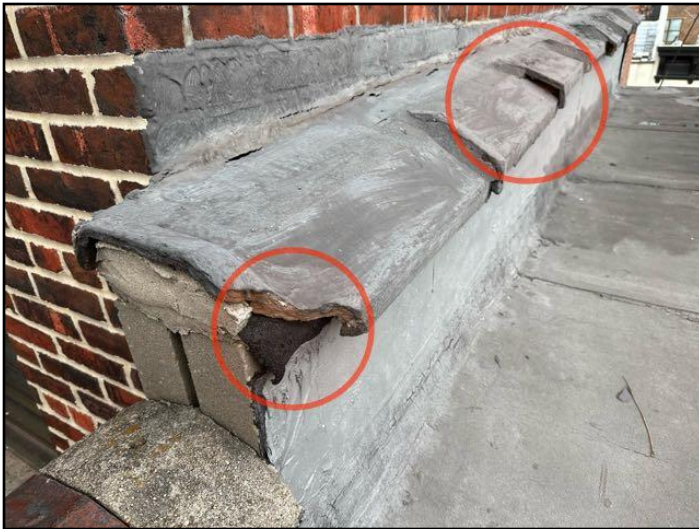
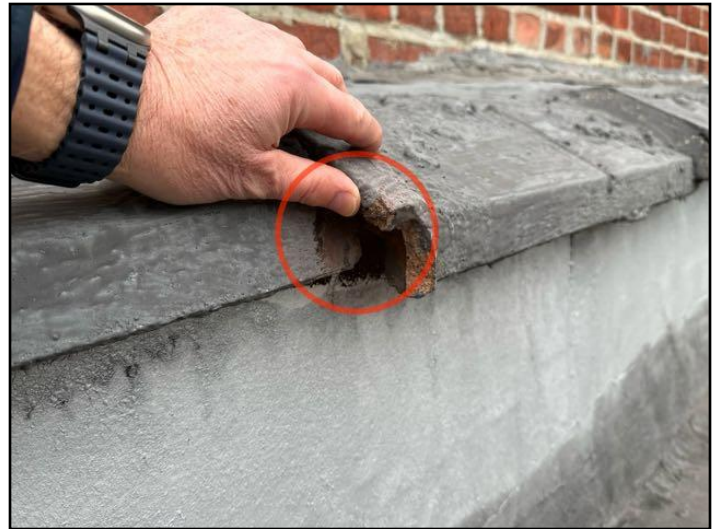
22. Condition: • Parapet wall coping damaged

Parapet wall coping damaged

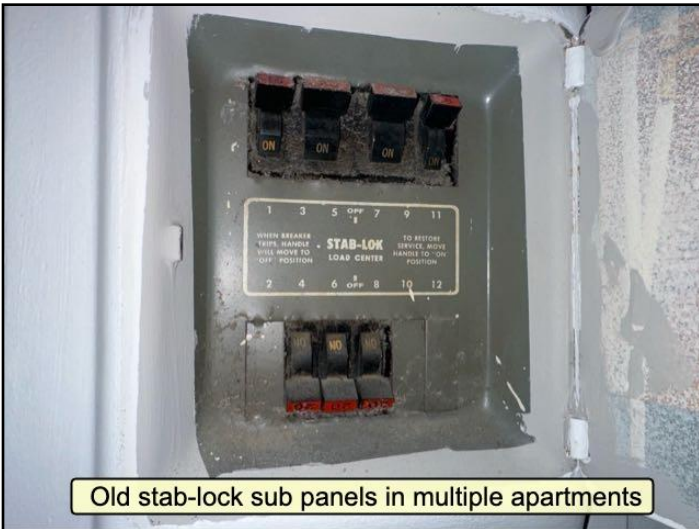
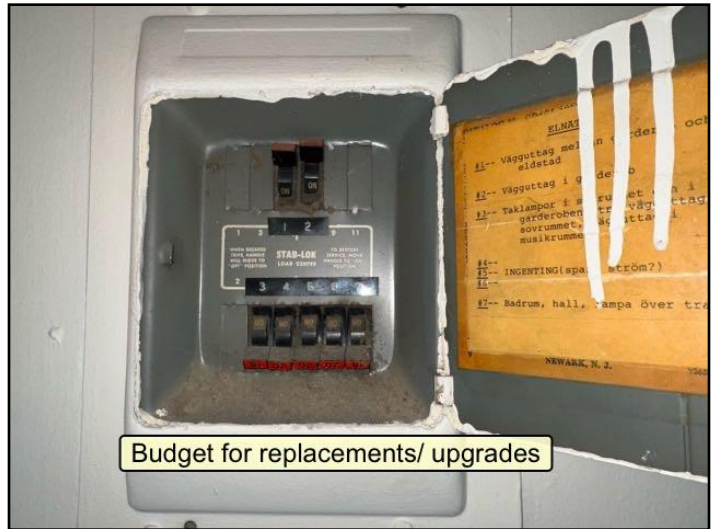
24. Condition: • Old Stab-Lock panel and breakers
Apartment 3F

Stab-Lok circuit breakers - particularly those manufactured by Federal Pacific Electric - have been noted as a serious safety hazard in homes. Stab-Lok circuit breakers are dangerous because they do not function properly as circuit breakers. The circuit "breaker," which is the switch that is supposed to flip and interrupt current flow when an issue is detected, does not function properly in these panels.. The circuit breakers are not effective for addressing issues like overloaded circuits and short circuits. Because the breakers may not trip when an issue is detected, this can damage home electrical systems, and even increase the risk of an electrical fire.

Old stab-lock sub panels in multiple apartments

Old Stab-Lock panel and breakers

Task: Replace

Budget for replacements/ upgrades

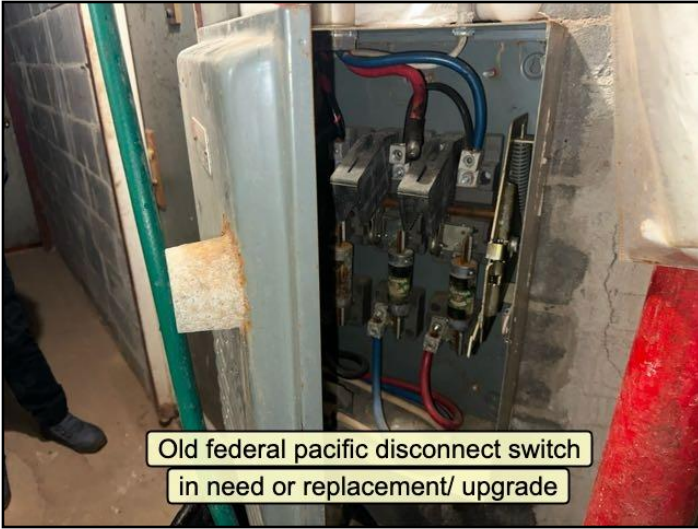
25. Condition: • Licensed electrician

Licensed electrician

****RECOMMEND LICENSED ELECTRICIAN FURTHER EVALUATE AND CORRECT ALL WIRING AND SAFETY CONCERNS PRIOR TO PURCHASE****.

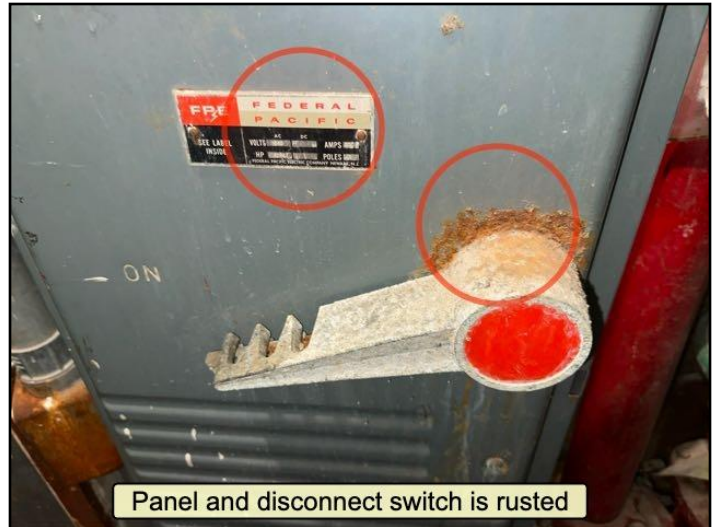
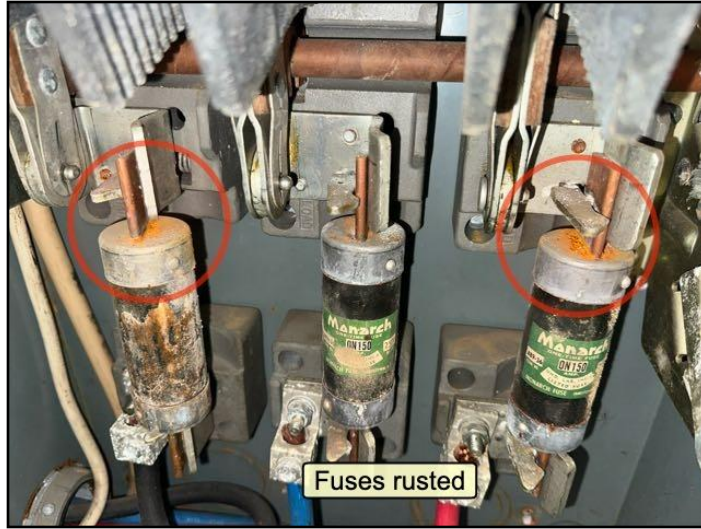
26. Condition: • Federal Pacific service panels can fail to trip in response to over current leading to electrical fires. Federal Pacific company no longer in business. Recommend licensed electrician replace panel.

Federal Pacific service panels can fail to...

****RECOMMEND LICENSED ELECTRICIAN FURTHER EVALUATE AND REPLACE. FEDERAL PACIFIC PANELS NO LONGER IN USE DO TO SAFETY CONCERNS.****

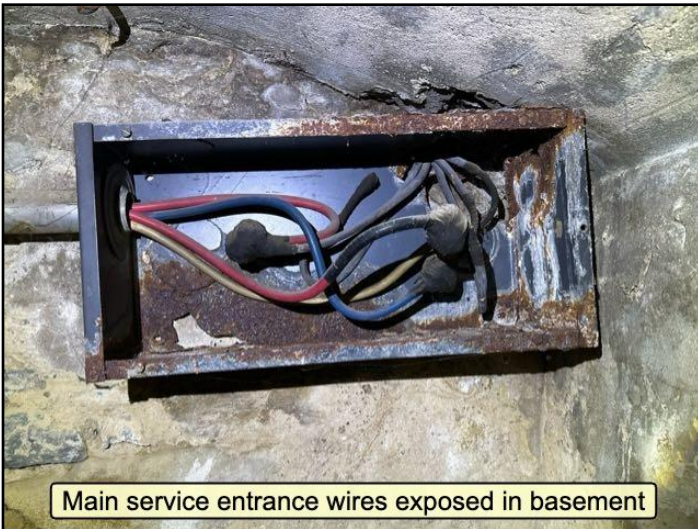
27. Condition: • WIRES EXPOSED

WIRES EXPOSED

Task: Repair

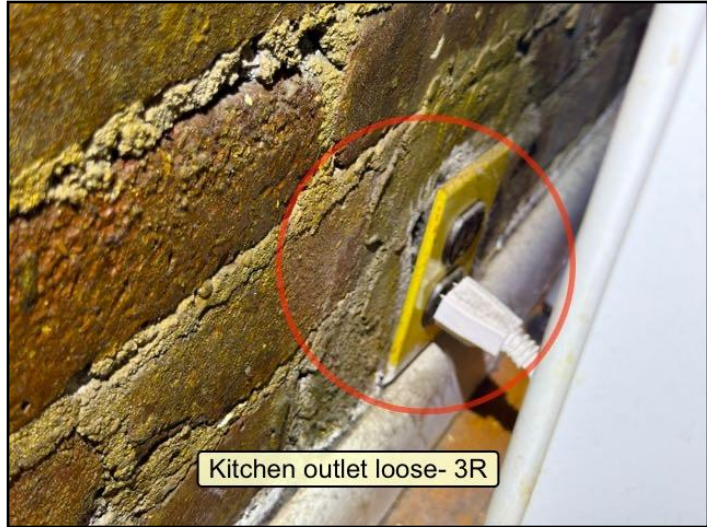
28. Condition: • [Loose](#)

Implication(s): Electric shock | Fire hazard

Loose

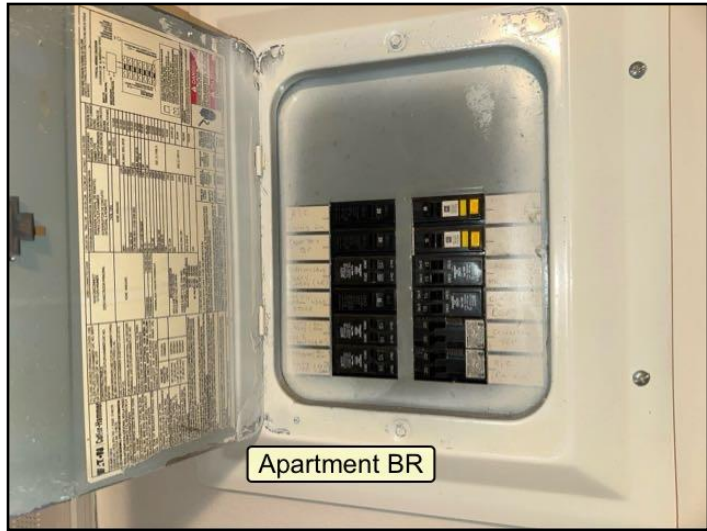
- Breakers
- Apartment BR

Apartment BR- sub panel

Budget for replacement of outdated / safety concern panels

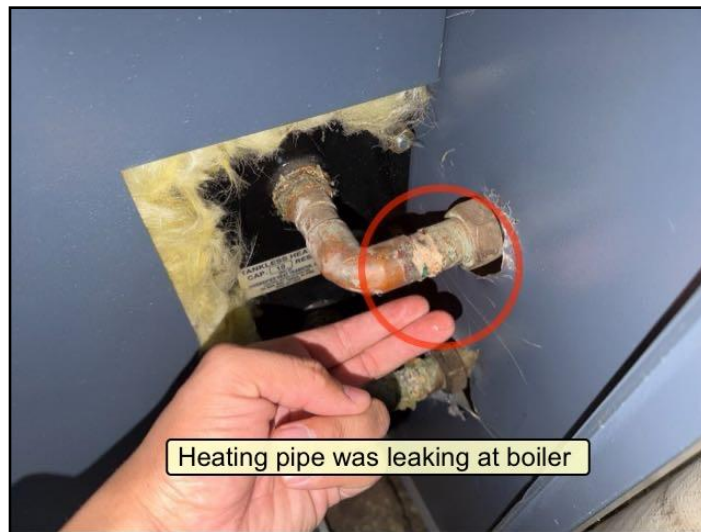
31. Condition: • Leaking

Heating pipe was leaking at boiler

Leaking

Task: Service

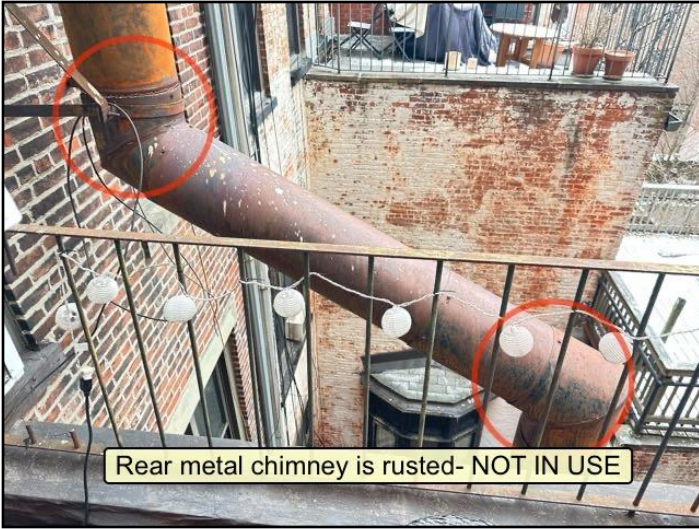
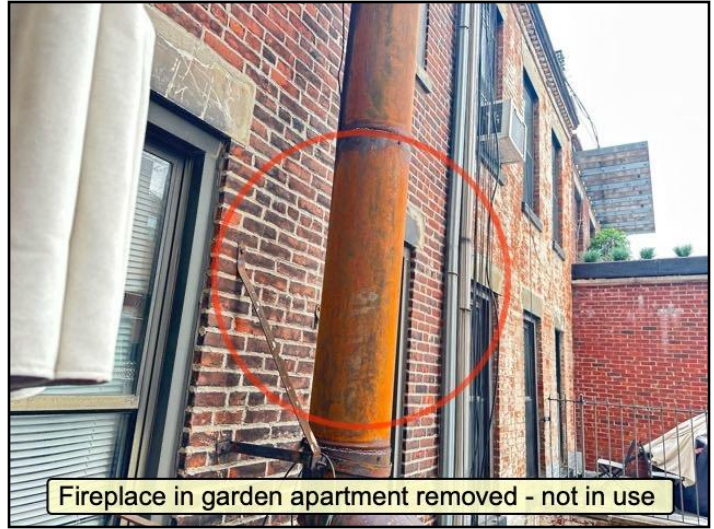
32. Condition: • [Chimney walls rusting or pitting](#)

Rear metal chimney is rusted- NOT IN USE

Implication(s): Chance of movement | Hazardous combustion products entering home

Chimney walls rusting or pitting

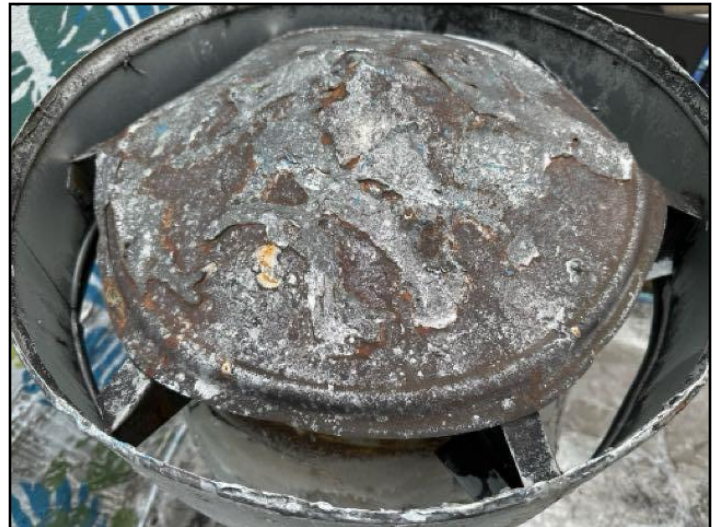
33. Condition: • Rust

Rust

Task: Replace

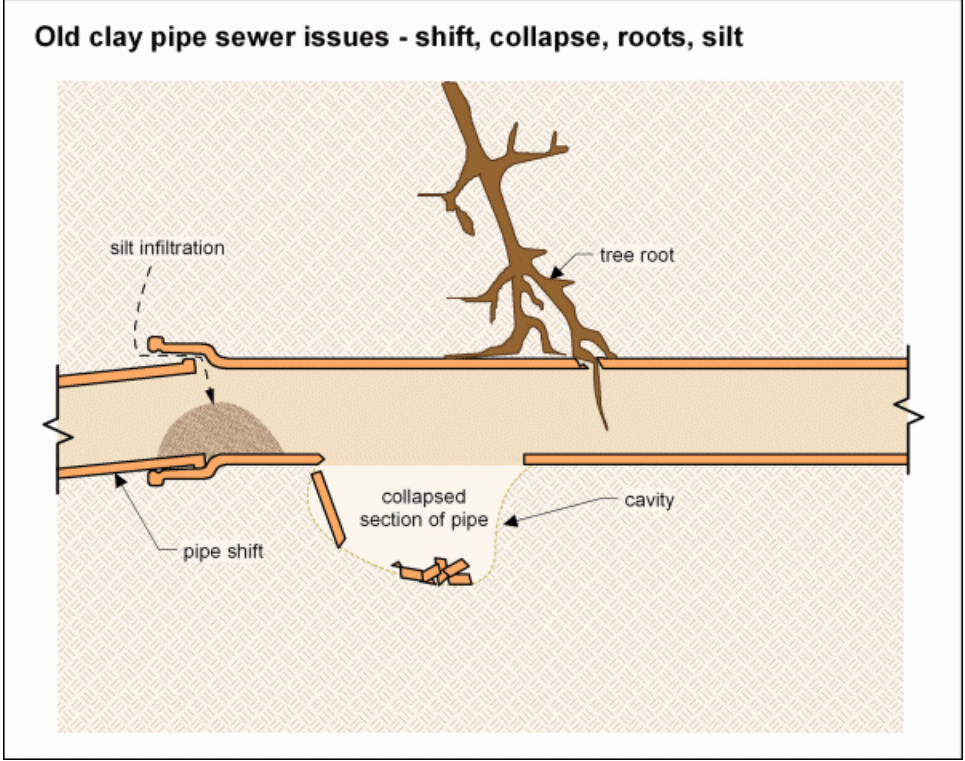
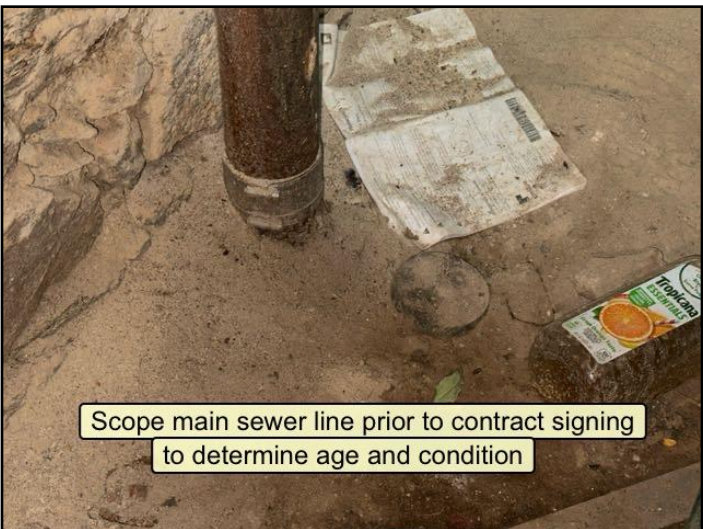
34. Condition: • Scope main sewer line

Scope main sewer line

RECOMMEND HAVING MAIN SEWER LINE SCOPED TO DETERMINE CONDITION OF LINE PRIOR TO CONTRACT SIGNING.

****_ADD SEWER LINE AND WATER MAIN INSURANCE THRU WATER COMPANY **_!!!!!!!!!!!!**

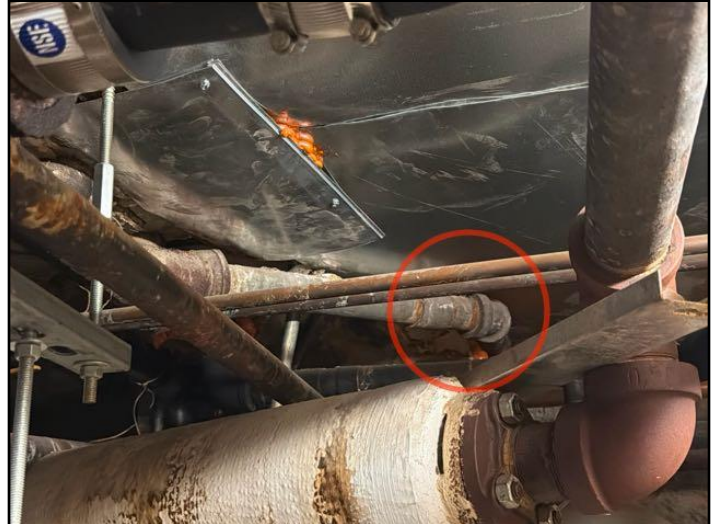
35. Condition: • Old galvanized drains
Various old galvanized drains still in use replace as needed
Location: Various
Task: Replace
Time: As soon as practical

Old galvanized drains

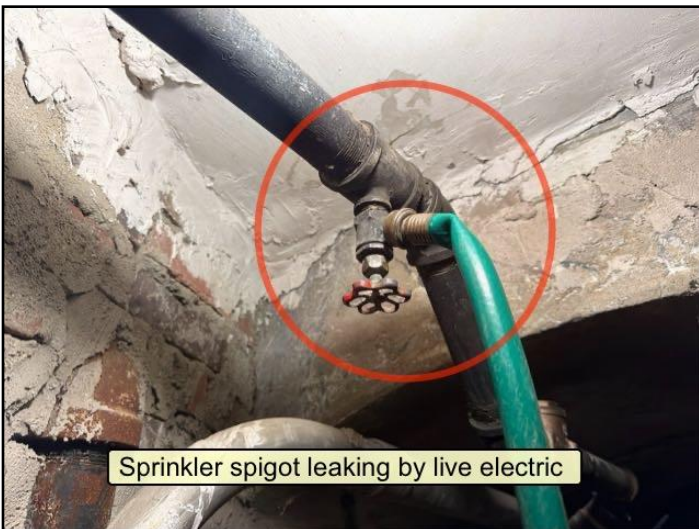
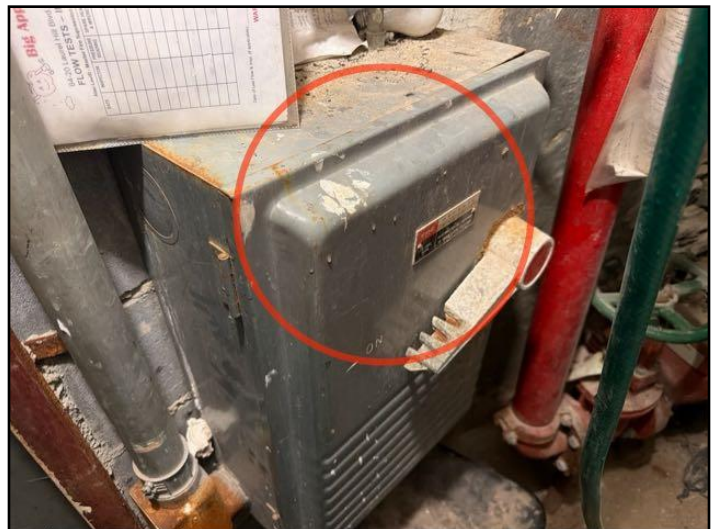
36. Condition: • [Leak](#)
Implication(s): Chance of water damage to structure, finishes and contents | System inoperative
Location: Basement
Task: Service
Time: Immediate

Leak

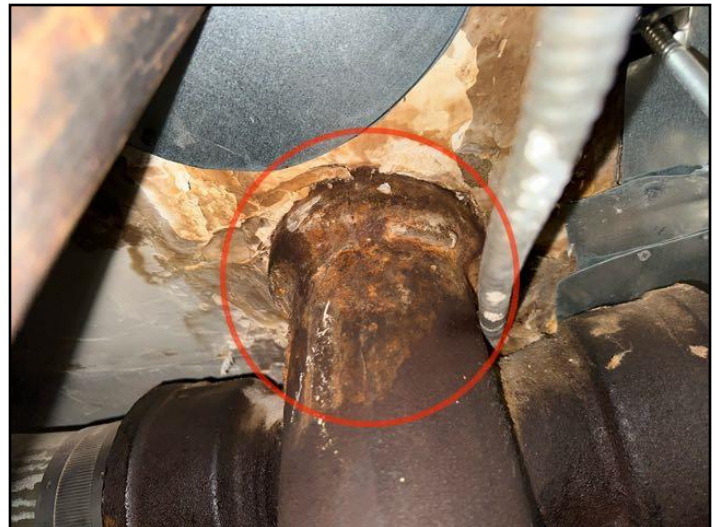
37. Condition: • [Rust](#)

Rust

Task: Replace

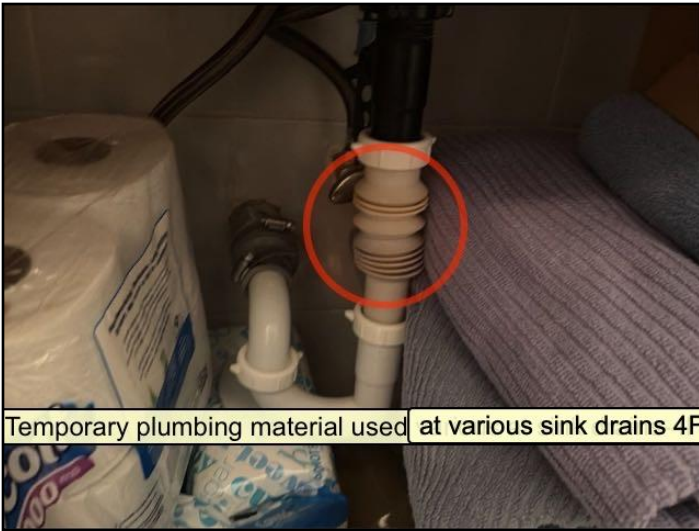
38. Condition: • Temporary plumbing materials

The flexible, corrugated drain pipe observed under the sink is a temporary plumbing material that can trap debris and restrict water flow, increasing the risk of clogs and odors. Replacement with solid, smooth-wall PVC or ABS piping is recommended for improved durability and proper drainage performance.

Temporary plumbing material used at various sink drains 4F

Task: Replace

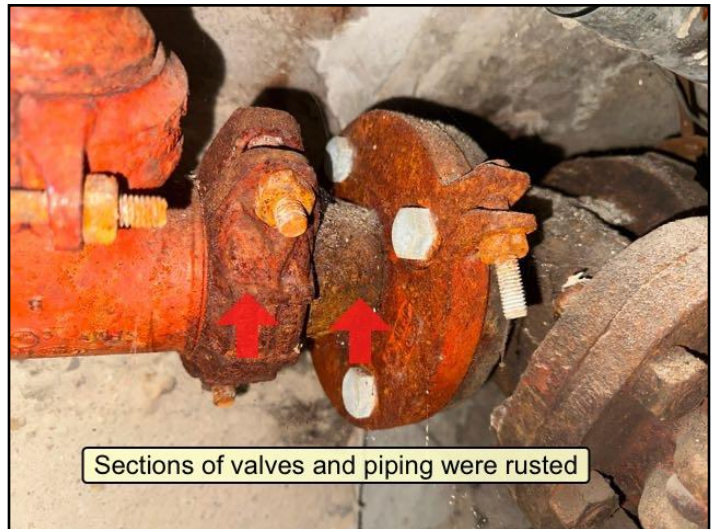
Sections of valves and piping were rusted

Sprinkler system

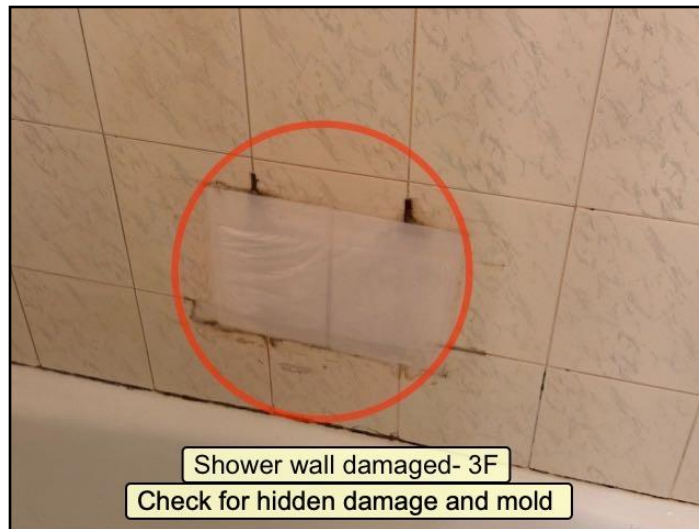
40. Condition: • Damage

Implication(s): Damage or physical injury due to falling materials

Damage

Task: Improve

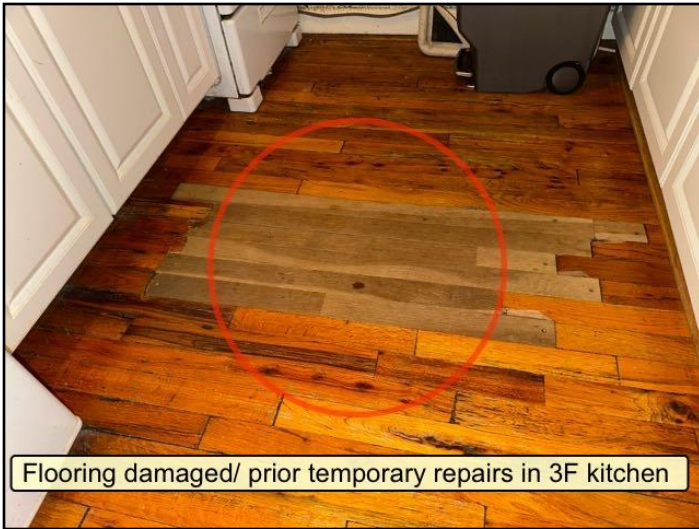
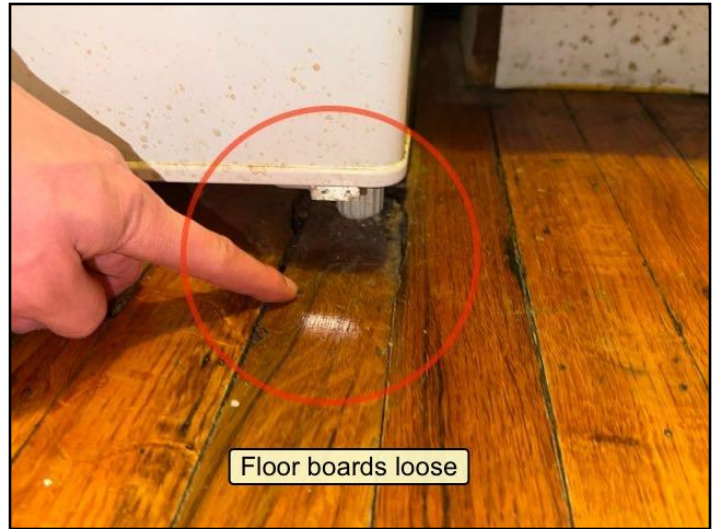
41. Condition: • Damaged

Flooring damaged/ prior temporary repairs in 3F kitchen

Damaged

Floor boards loose

Task: Repair

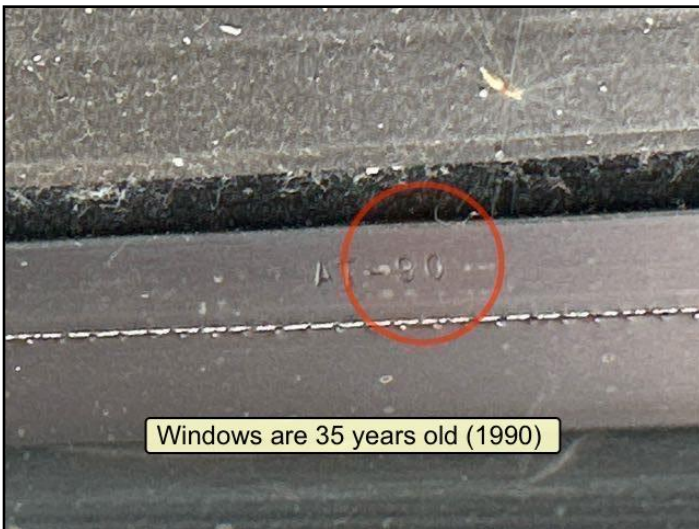
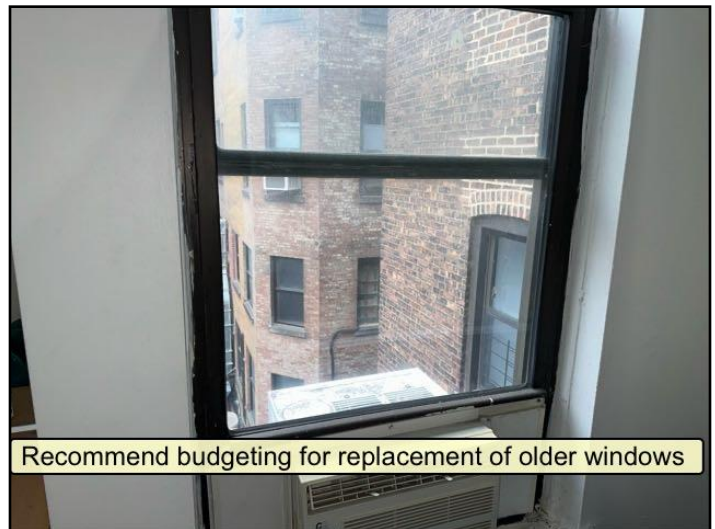
42. Condition: • Older windows
Windows are 35 years old (1990)

Windows are 35 years old (1990)

Older windows

Task: Budget for replacements

Recommend budgeting for replacement of older windows

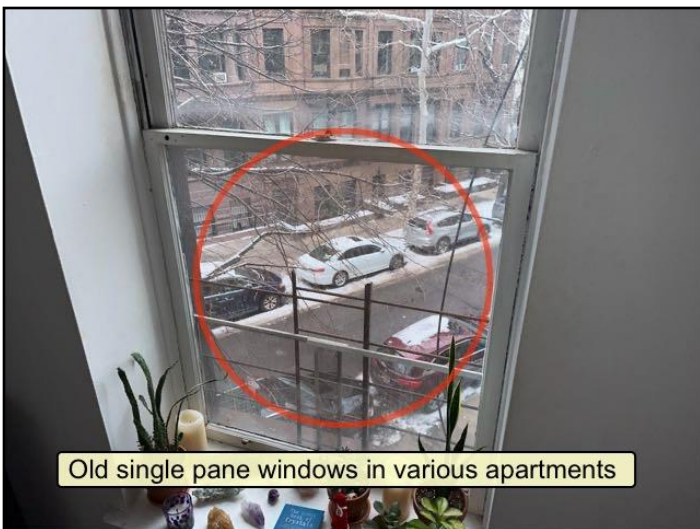
44. Condition: • Old single pane glass

Various windows throughout building are old with single pane glass. These windows lack proper insulation. Recommend upgrading.

Old single pane glass

Recommend budgeting for replacements

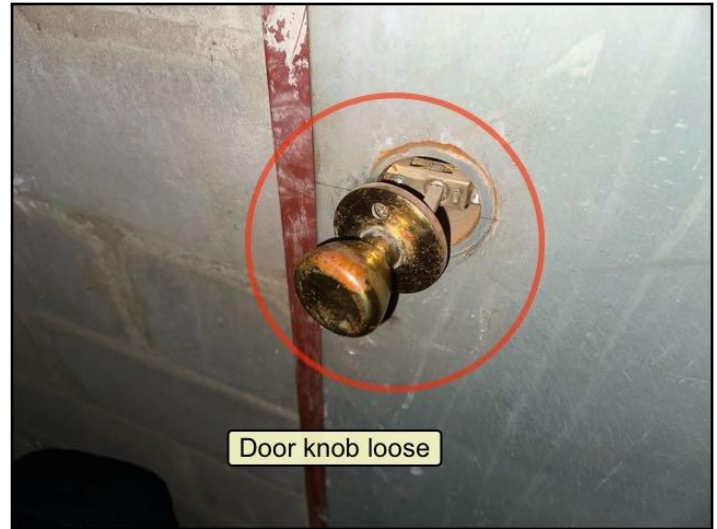
45. Condition: • [Loose or poor fit](#)

Sprinkler/ Electric room door was stiff

Door knob loose

Loose or poor fit

Task: Repair or replace

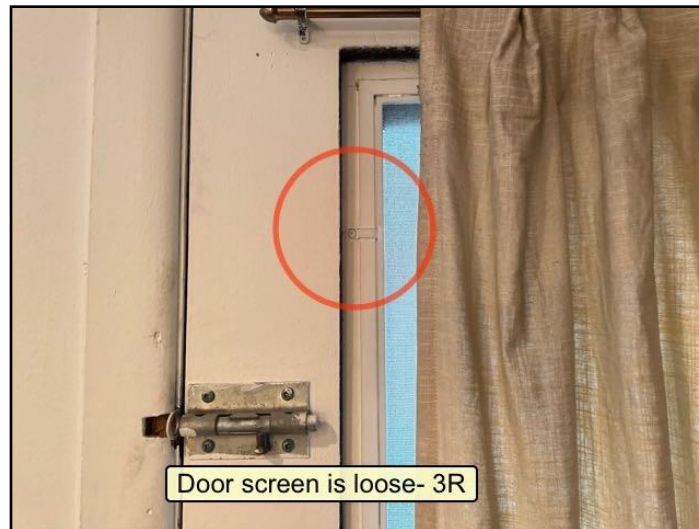
46. Condition: • [Loose](#)

Door screen is loose- 3R

Loose

Task: Repair or replace
