INSPECTION REPORT

For the Property at:
123 MAIN ST
NEW YORK, NY 10023

Prepared for: JOHN SMITH
Inspection Date: Monday, December 15, 2025
Prepared by: Robert Byrne, License# 16000062890

RE: Report No. 2985, v.4
123 main st
New York, NY
10023

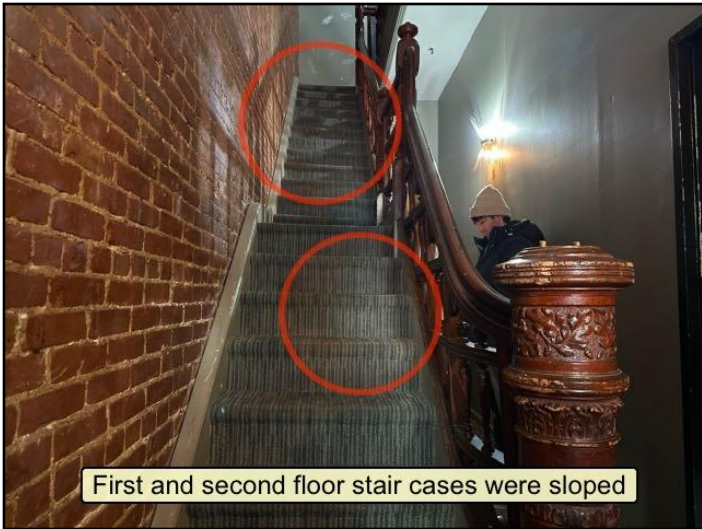
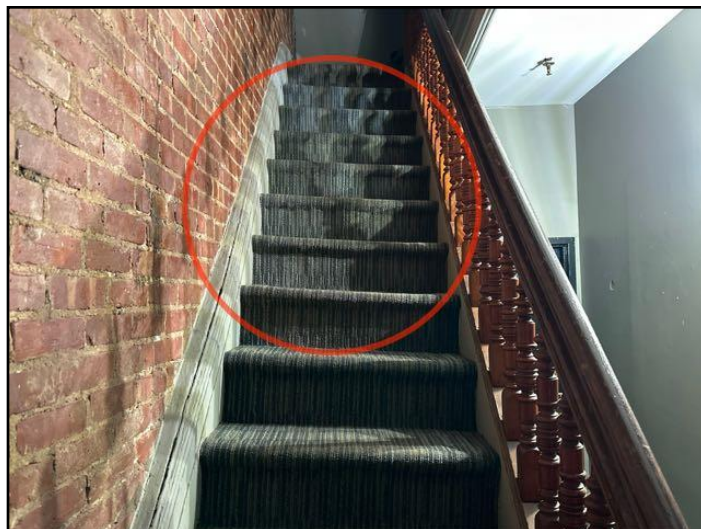
48. Condition: • [Sloped](#)

Implication(s): Trip or fall hazard

First and second floor stair cases were sloped

Sloped

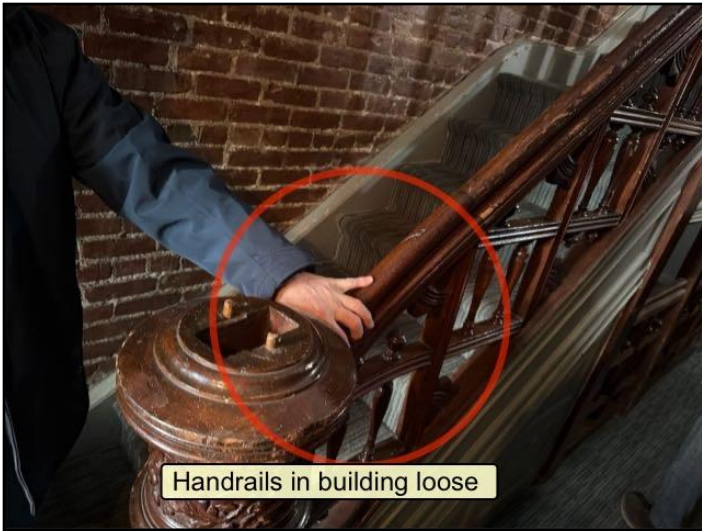
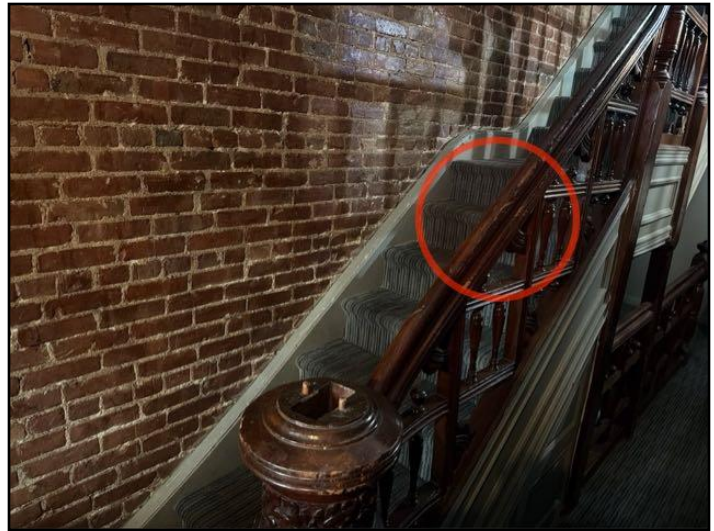
50. Condition: • [Loose](#)

Implication(s): Fall hazard

Loose

Task: Improve
