# INSPECTION REPORT

Prepared by: Robert Byrne, License# 16000062890

Report No. 3081

5 Bouton Point Road, Lloyd Harbor, NY April 11, 2026

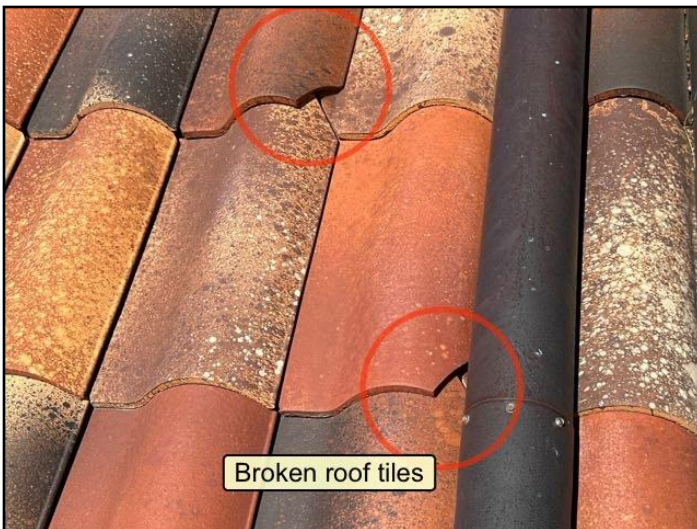
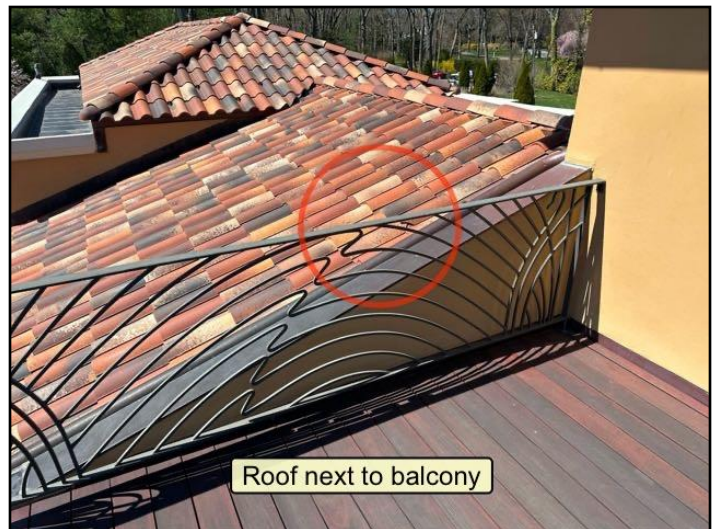
**2. Condition:** • [Missing, loose or broken pieces](#)

**Implication(s):** Chance of water damage to structure, finishes and contents | Damage or physical injury due to falling materials

**Location:** Right Side

Missing, loose or broken pieces

**Task:** Repair

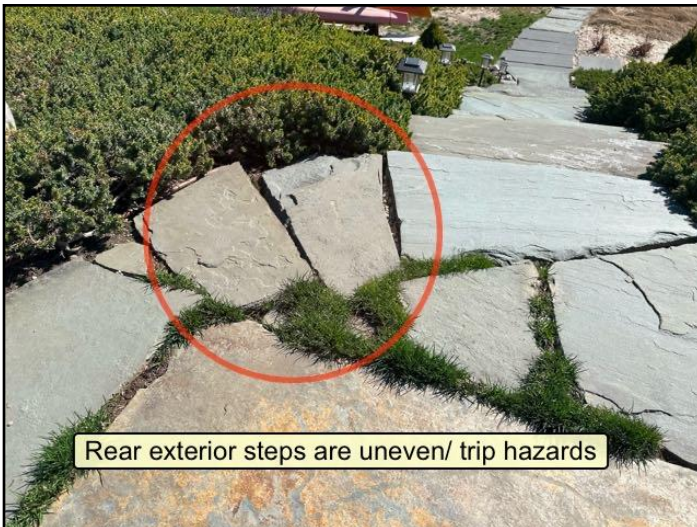
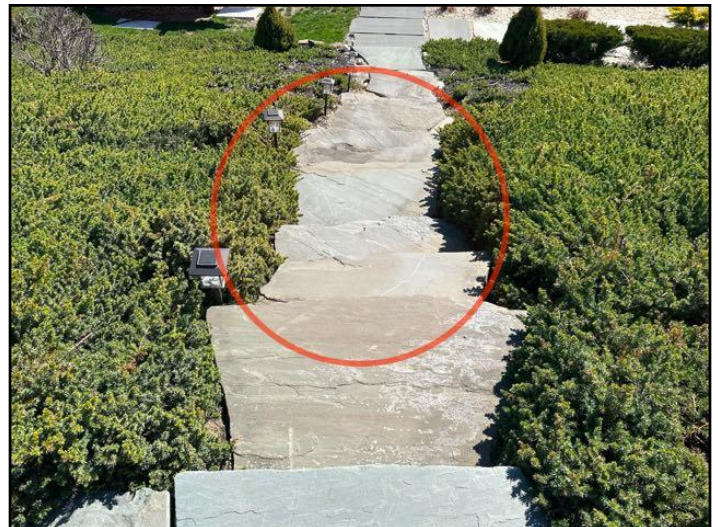
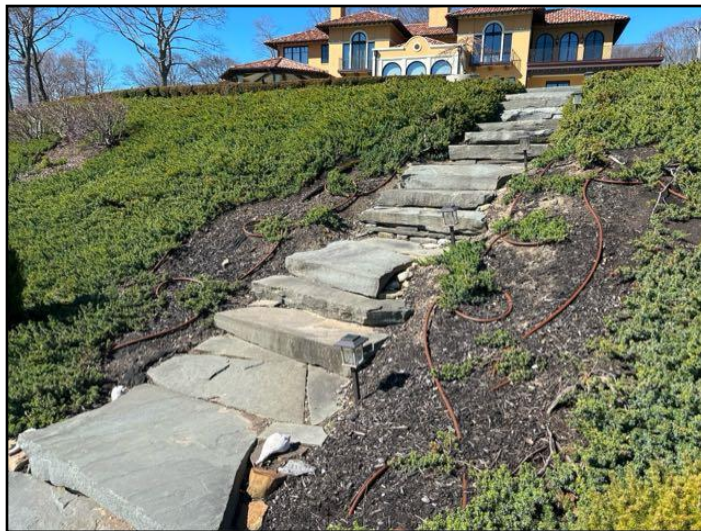
**PORCHES, DECKS, STAIRS, PATIOS \ \*Stairs and landings\*****7. Condition:** • Trip hazard**Implication(s):** Trip or fall hazard**Location:** Rear**Task:** Improve**Walkway steps**

*Trip hazard*

Trip hazard

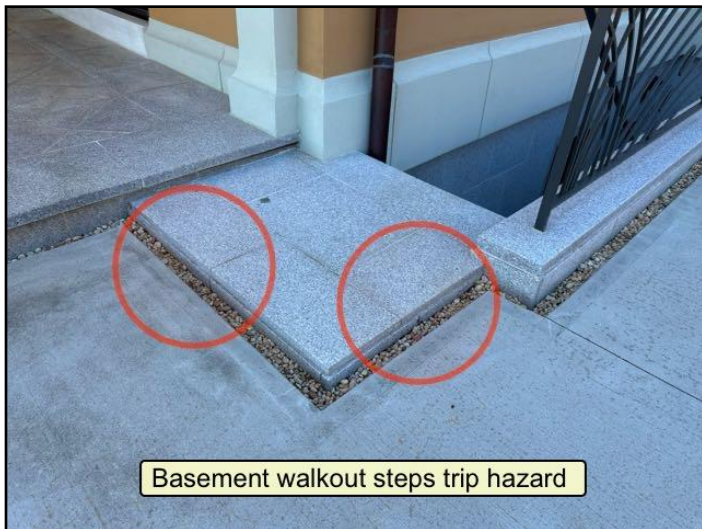
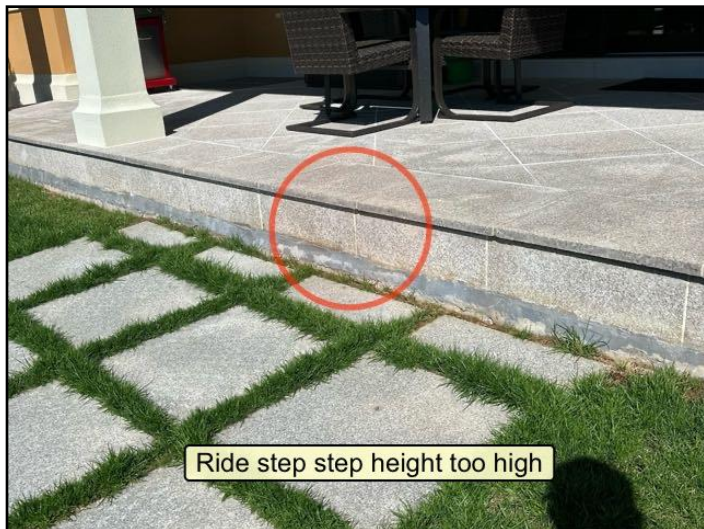
**8. Condition:** • Trip hazard

**Implication(s):** Trip or fall hazard

**Location:** Left Side & Right side

Trip hazard

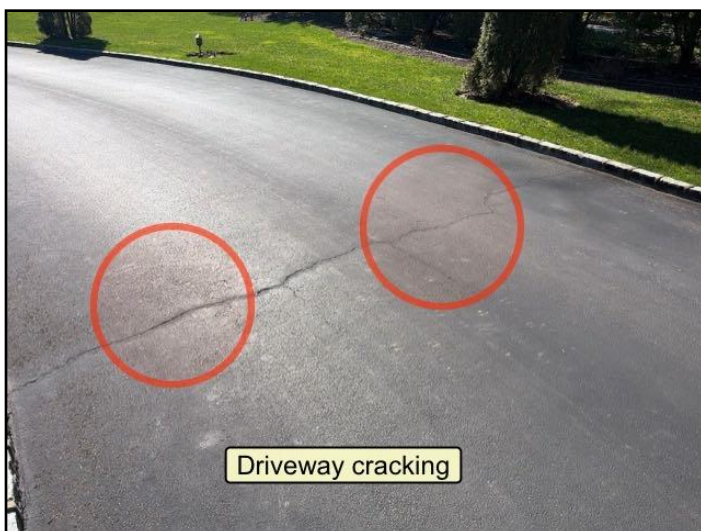
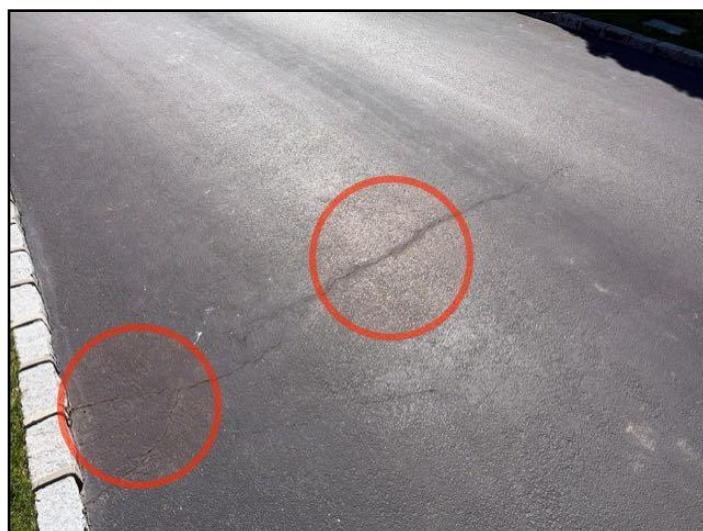
**11. Condition:** • [Cracked or damaged surfaces](#)

**Implication(s):** Trip or fall hazard

*Cracked or damaged surfaces*

**Task:** Repair

**Time:** As soon as practical

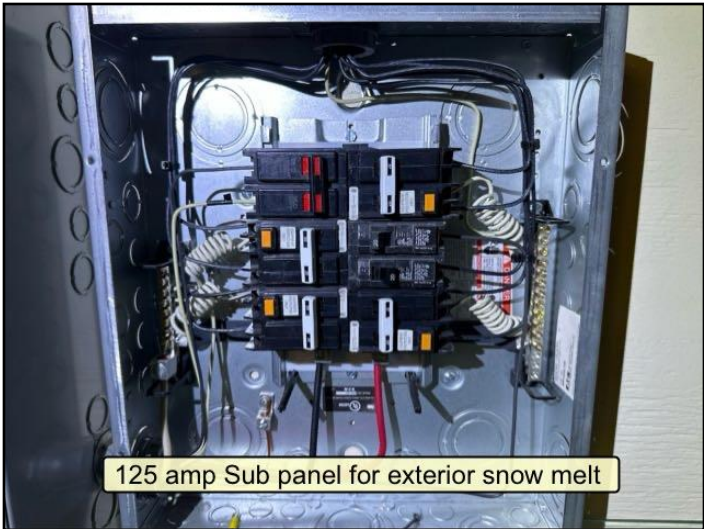
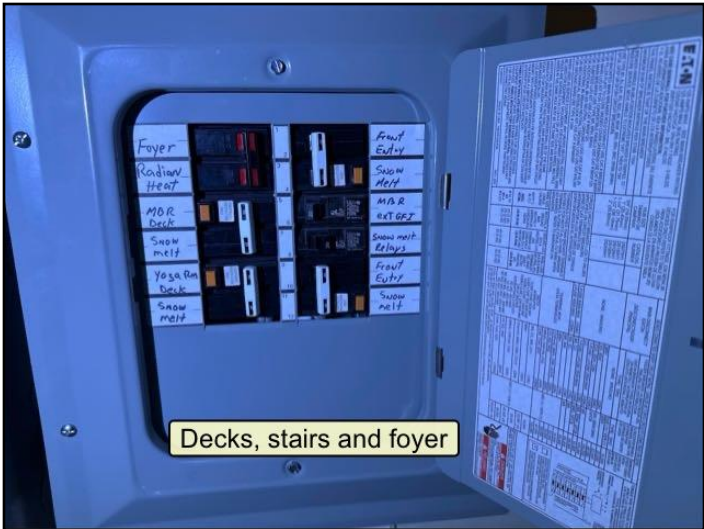
125 amp Sub panel for exterior snow melt- Decks, stairs and foyer

125 amp Sub panel for exterior snow melt

Decks, stairs and foyer

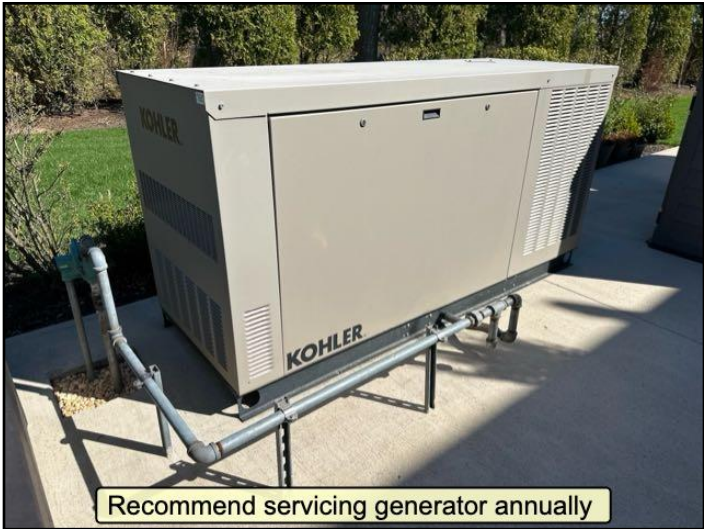
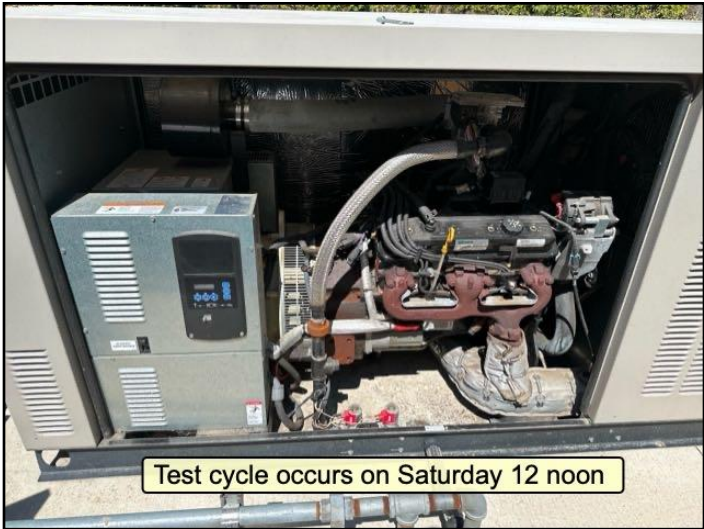
- Generator
- Kohler generator is 11 years old- Service annually

Standby generator (Kohler 48RCL, ~2015) is installed to provide backup power. Unit appeared intact at time of inspection; Generators require regular servicing and were not load-tested. Recommend verifying recent maintenance and having the system serviced and tested by a qualified technician prior to closing.

Test cycle occurs on Saturday 12 noon

Recommend servicing generator annually

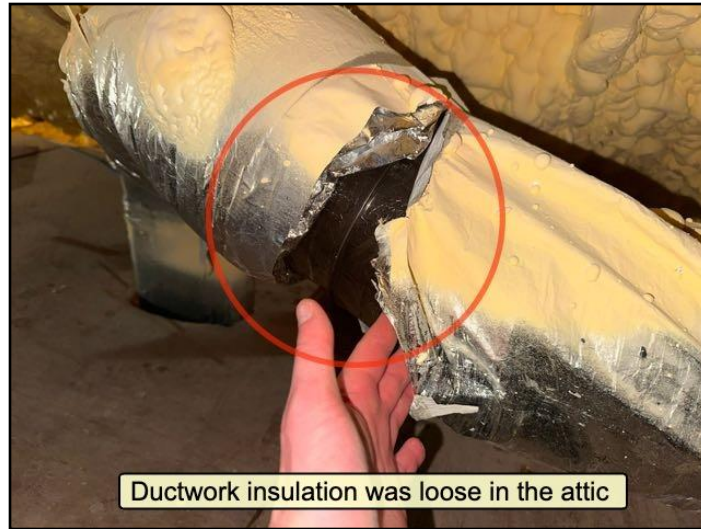
**17. Condition:** • Ductwork insulation loose or missing

Ductwork insulation was loose in the attic

*Ductwork insulation loose or missing*

**Task:** Repair

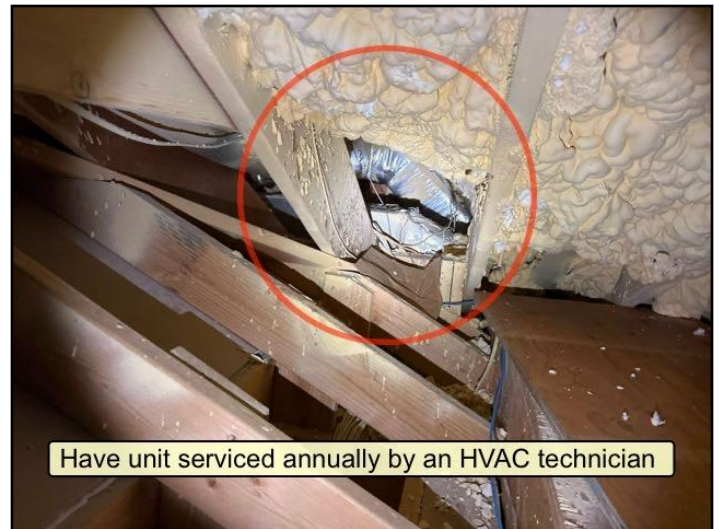
Attic air handler was inaccessible

*No access to Air Handler*

Have unit serviced annually by an HVAC technician

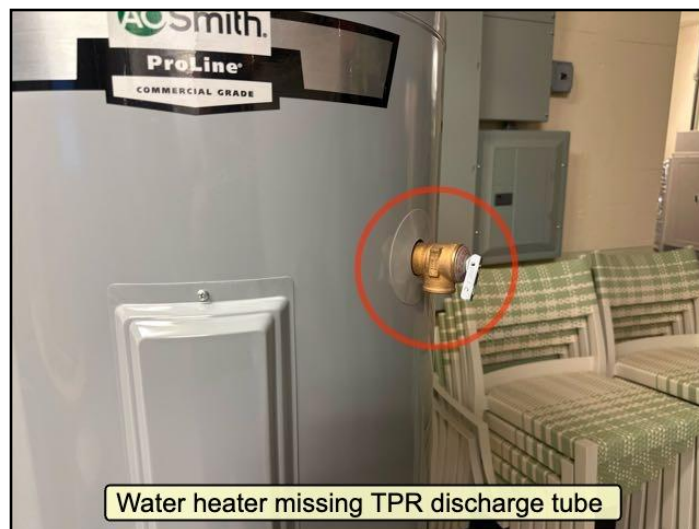
18. Condition: • [Discharge tube missing](#)

Discharge tube missing

Task: Provide

Time: As soon as practical

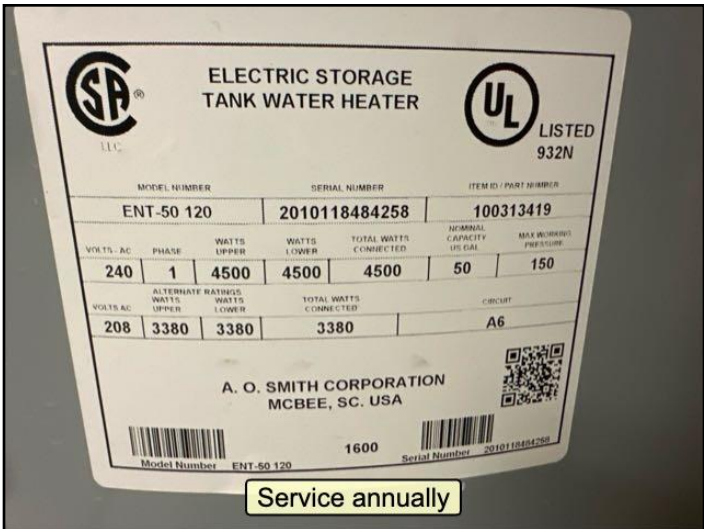
AO Smith water heater approximately 6 years old

Service annually
