# INSPECTION REPORT

Prepared by: Robert Byrne, License# 16000062890

Higher Elevation Home & Commercial Inspections LLC  
188 Brown Street  
Sea Cliff, NY 11579  
(516) 509- 9091

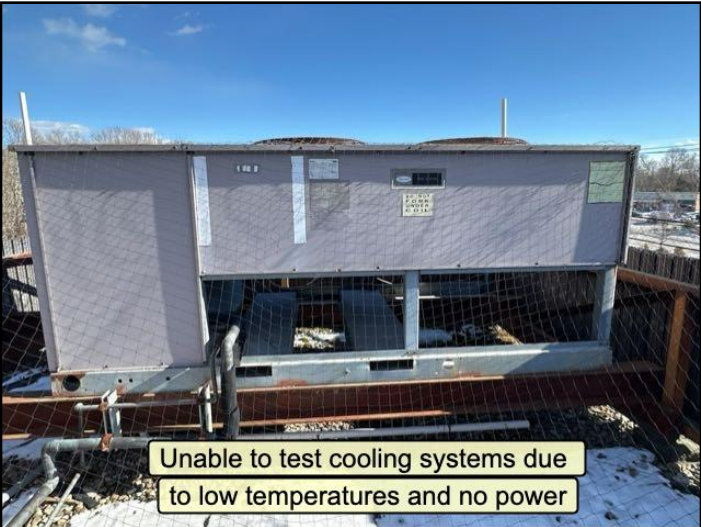
- Power turned off
- Unable to test cooling systems due to low temperatures and no power

Power turned off

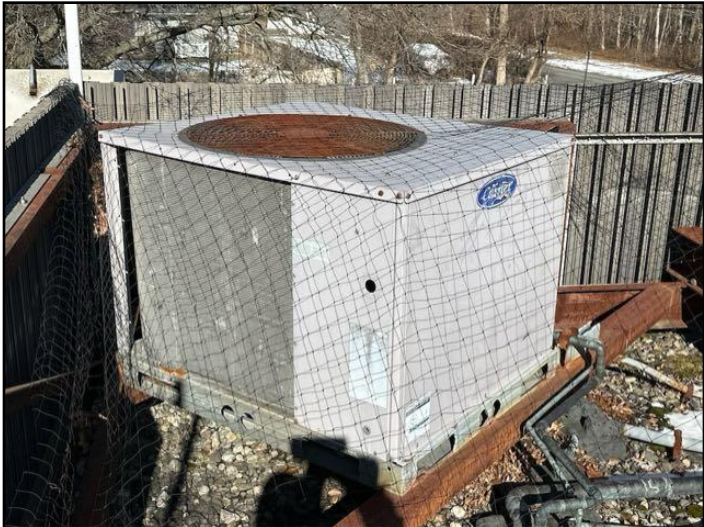
Power turned off

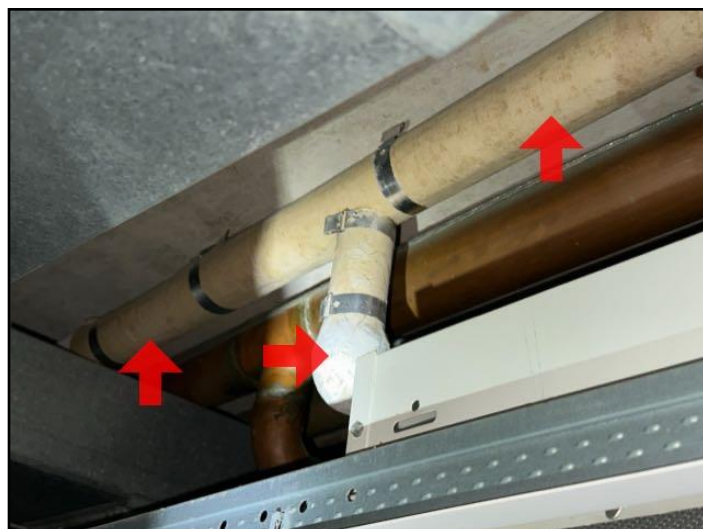
*Broken***POTENTIALLY HAZARDOUS MATERIALS \ General notes****42. Condition:** • Possible asbestos containing materials

Asbestos is a fibrous material that was used in many building materials as a fire resistant material, a binder, and a thermal insulator. The very small asbestos fibers can cause cancer and other types of lung disease if inhaled. Demolition or renovation work can disturb asbestos-containing materials, causing the asbestos fibers to be released into the air. Various heating pipes have possible asbestos contain material. Corrective actions related to asbestos should not be undertaken by the property owner, as a general rule. Recommend further evaluation by a licensed environmental specialist company to provide cost of removal.

**Implication(s):** Health hazard**Location:** Basement/ Attic

*Possible asbestos containing materials*
