INSPECTION REPORT

For the Property at:
123 MAIN ST
NEW YORK, NY 10023

Prepared for: JOHN SMITH
Inspection Date: Monday, December 15, 2025
Prepared by: Robert Byrne, License# 16000062890

RE: Report No. 2985, v.4
123 main st
New York, NY
10023

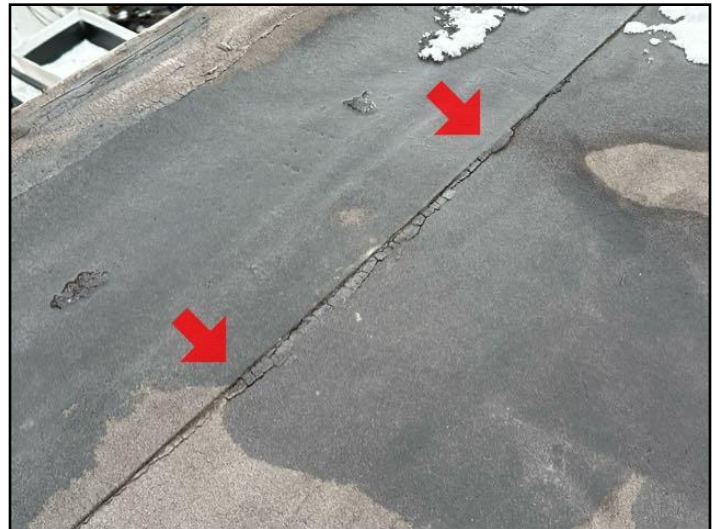
2. Condition: • [Openings at seams or flashings](#)

Recommend replacing roofing material and properly flashing various areas of concern on the roof. Repair attempts on roof are not done professionally and are a major concern for future leaks.

Implication(s): Chance of water damage to structure, finishes and contents

Openings at seams or flashings

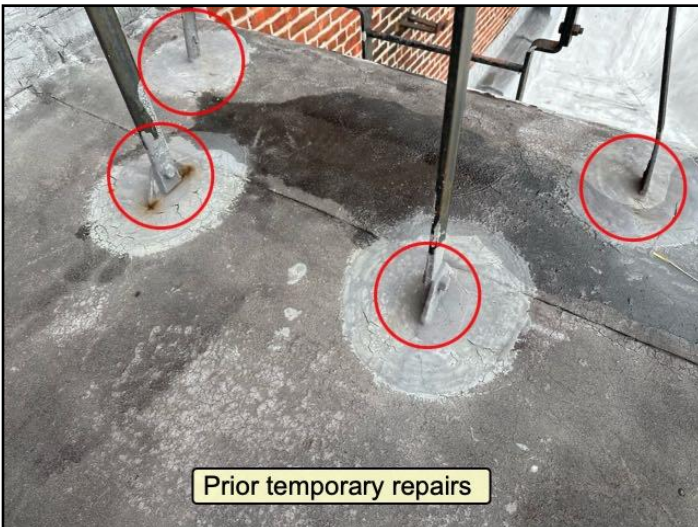
Openings at seams or flashings

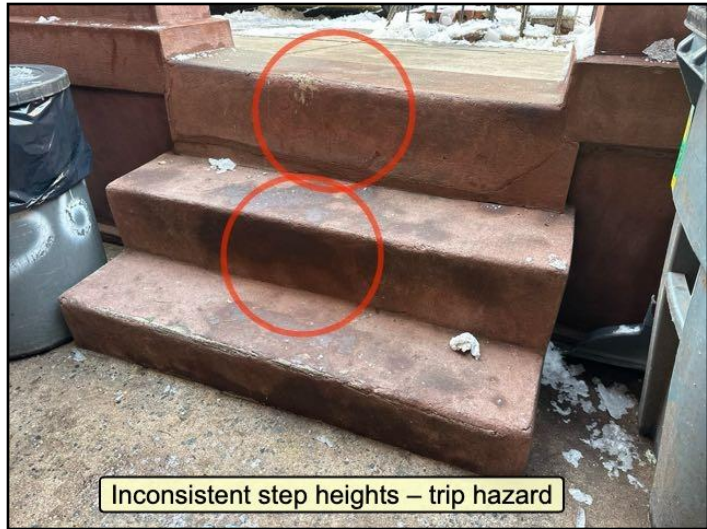
Stair rise too big or not uniform

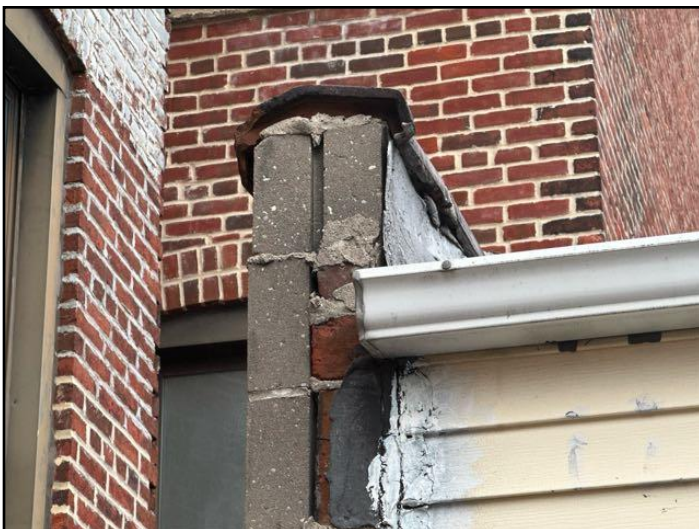
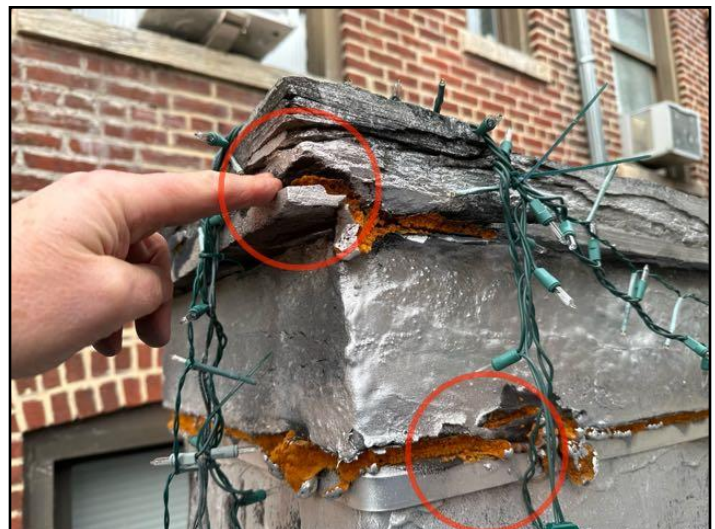
Parapet wall coping damaged

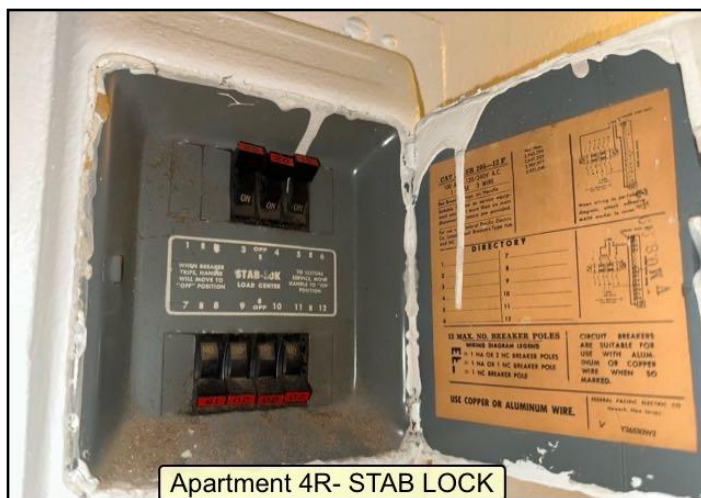
Stab-Lok circuit breakers - particularly those manufactured by Federal Pacific Electric - have been noted as a serious safety hazard in homes. Stab-Lok circuit breakers are dangerous because they do not function properly as circuit breakers. The circuit "breaker," which is the switch that is supposed to flip and interrupt current flow when an issue is detected, does not function properly in these panels.. The circuit breakers are not effective for addressing issues like overloaded circuits and short circuits. Because the breakers may not trip when an issue is detected, this can damage home electrical systems, and even increase the risk of an electrical fire.

Apartment 4R- STAB LOCK

Budget for replacement of outdated / safety concern panels

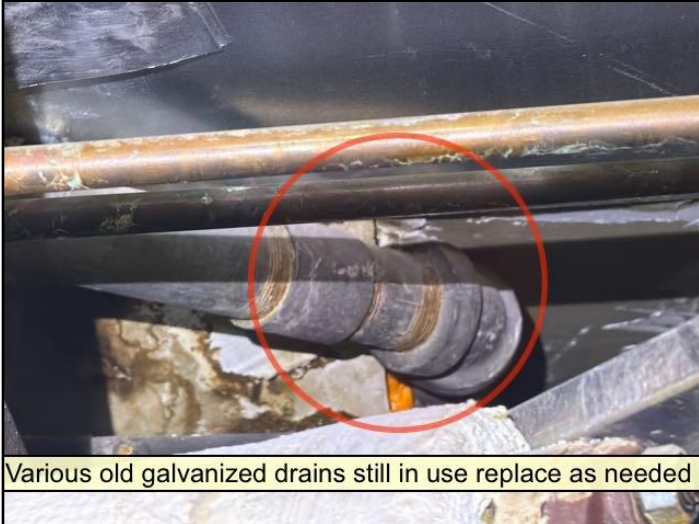
35. Condition: • Old galvanized drains
Various old galvanized drains still in use replace as needed
Location: Various
Task: Replace
Time: As soon as practical

Old galvanized drains

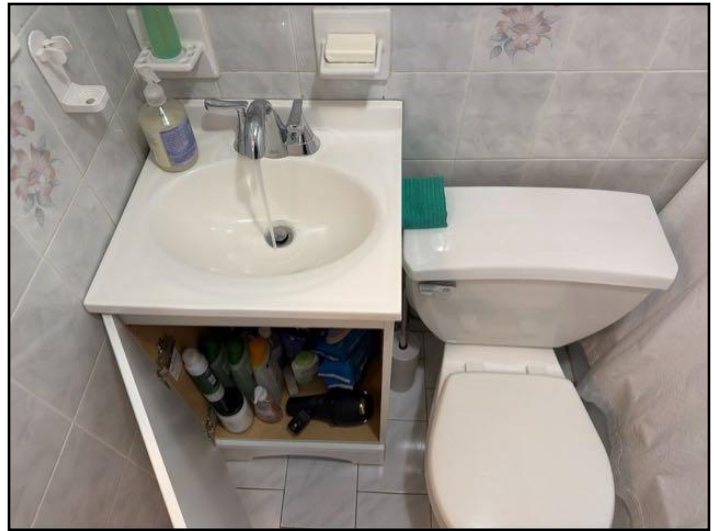
38. Condition: • Temporary plumbing materials

The flexible, corrugated drain pipe observed under the sink is a temporary plumbing material that can trap debris and restrict water flow, increasing the risk of clogs and odors. Replacement with solid, smooth-wall PVC or ABS piping is recommended for improved durability and proper drainage performance.

Temporary plumbing material used at various sink drains 4F

Temporary plumbing materials

Task: Replace

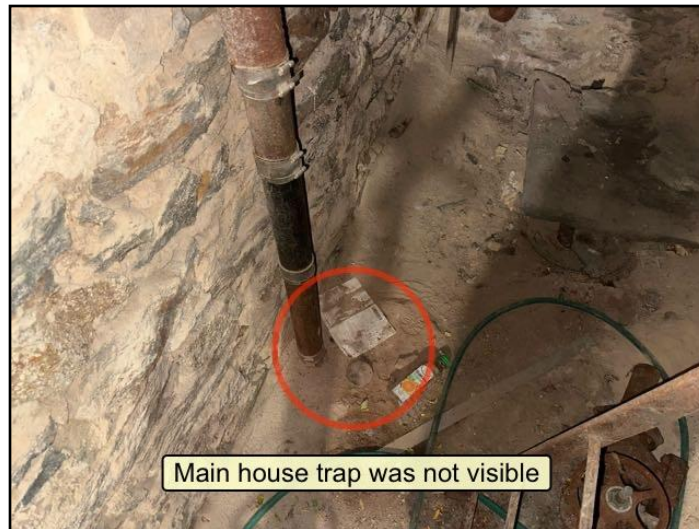
Main house trap not visible
