# INSPECTION REPORT

Prepared by: Robert Byrne, License# 16000062890

Higher Elevation Home & Commercial Inspections LLC  
188 Brown Street  
Sea Cliff, NY 11579  
(516) 509- 9091

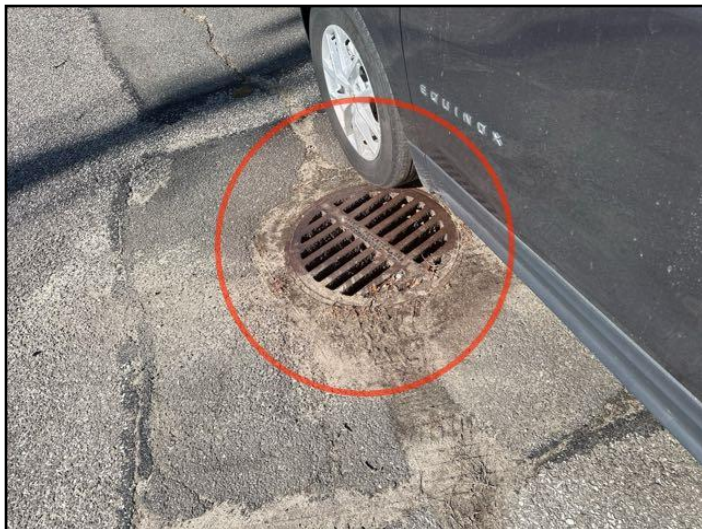
Keep outside drains clear of debris to...

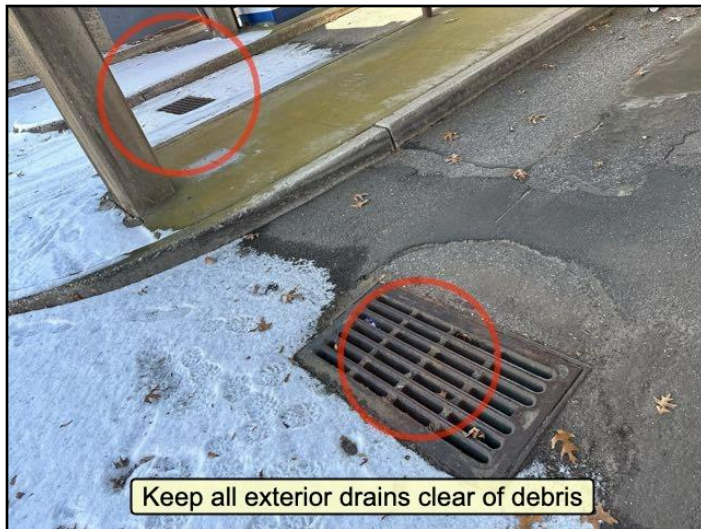
Keep outside drains clear of debris to...

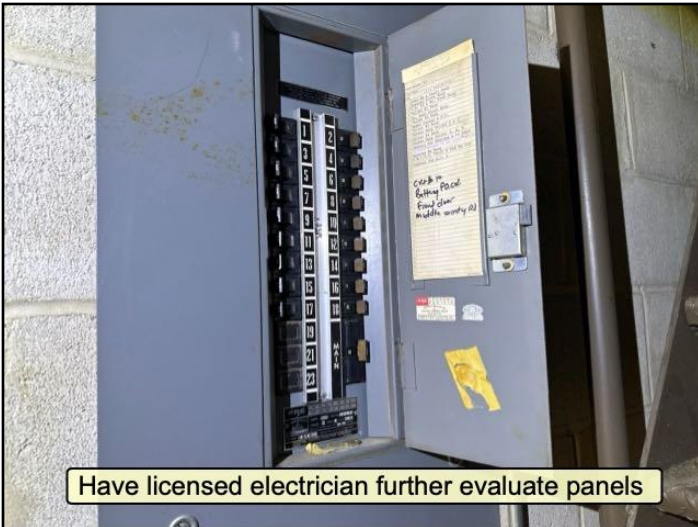
Multiple Federal Pacific panels in use

Have licensed electrician further evaluate panels

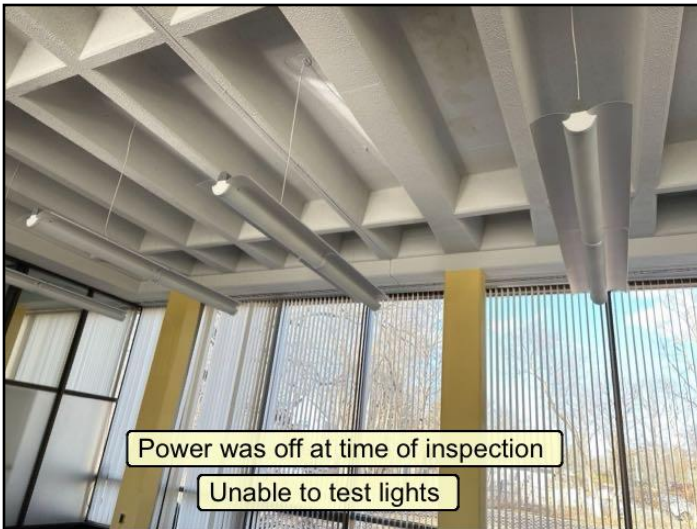
*Power was off*

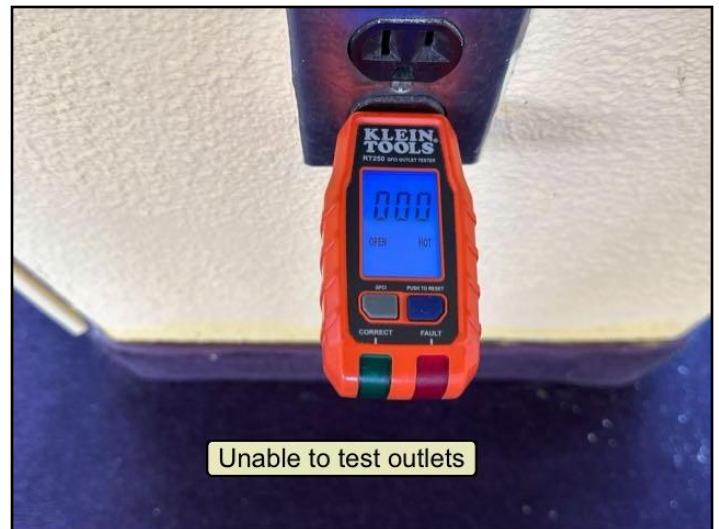
*Power was off*

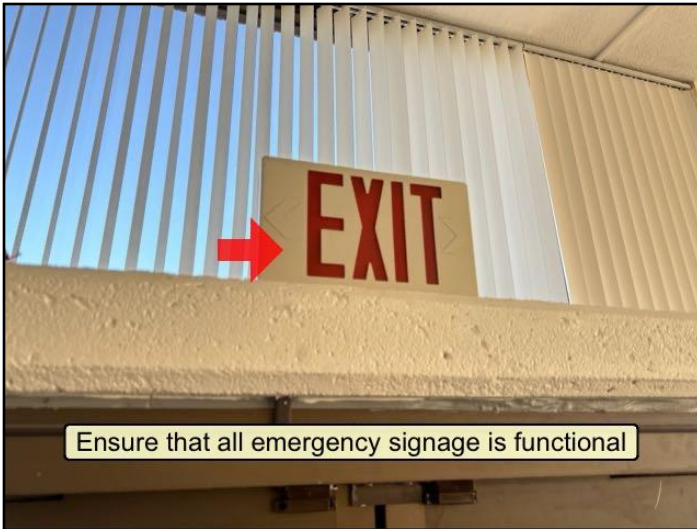
*Power was off*

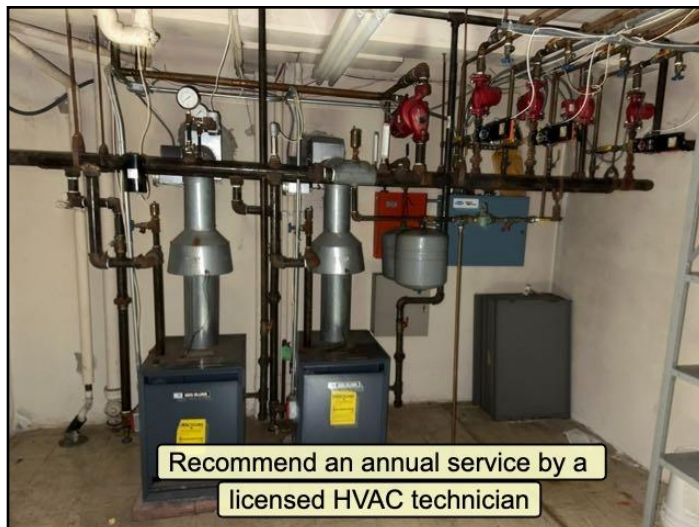
*Recommend an annual service contract with a...*

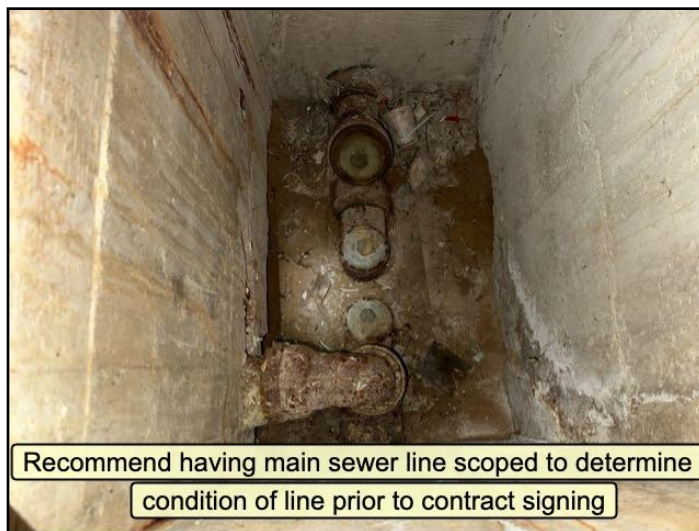
RECOMMEND HAVING MAIN SEWER LINE SCOPED TO DETERMINE CONDITION OF LINE PRIOR TO CONTRACT SIGNING.

*Scope main sewer line*

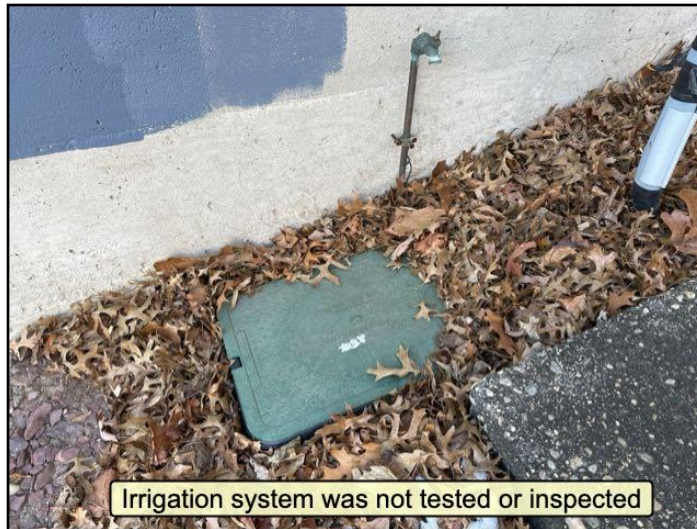
Irrigation system was not tested or inspected

*Landscape irrigation systems*

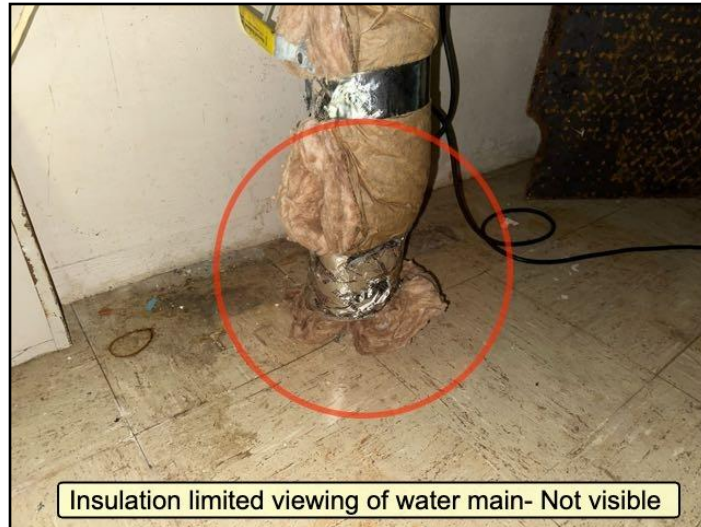
*Not visible*

Supply piping in building: • [Copper](#) • [Not visible](#)
