INSPECTION REPORT

For the Property at:
123 MAIN ST
NEW YORK, NY 10023

Prepared for: JOHN SMITH
Inspection Date: Monday, December 15, 2025
Prepared by: Robert Byrne, License# 16000062890

RE: Report No. 2985, v.4
123 main st
New York, NY
10023

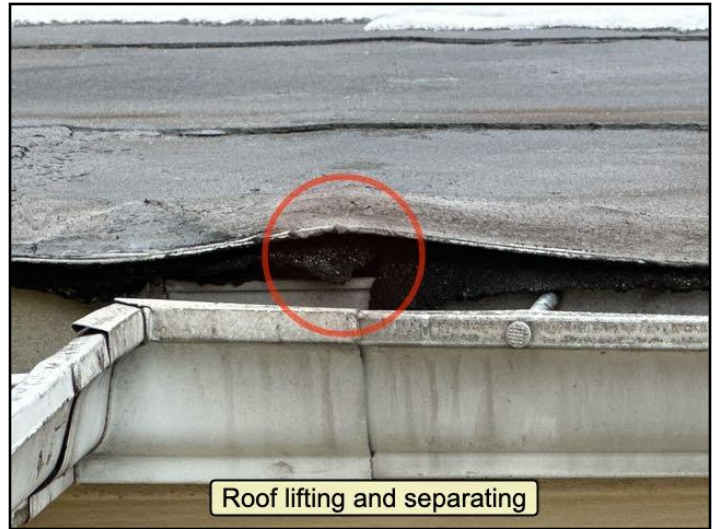
4. Condition: • [Multiple layers](#)

Multiple layers

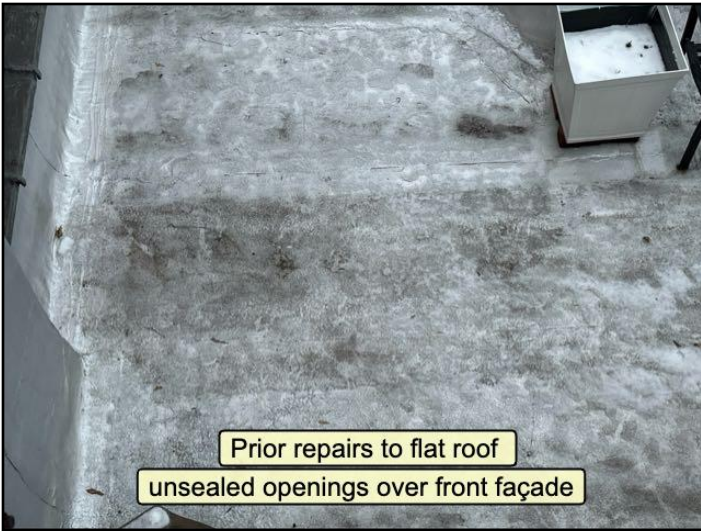
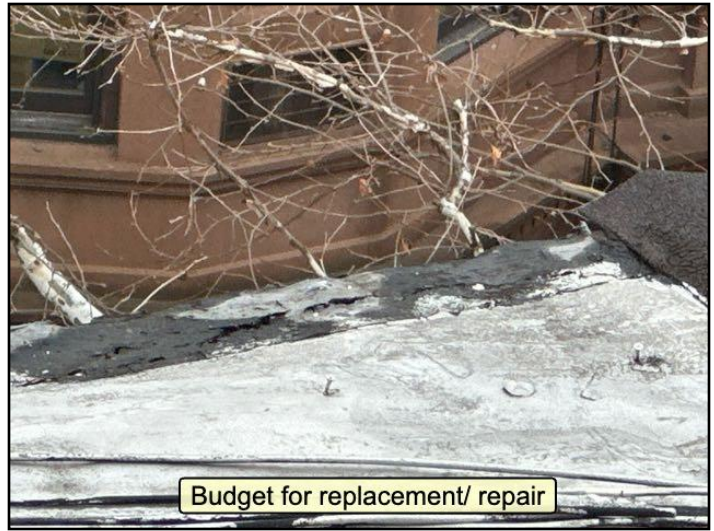
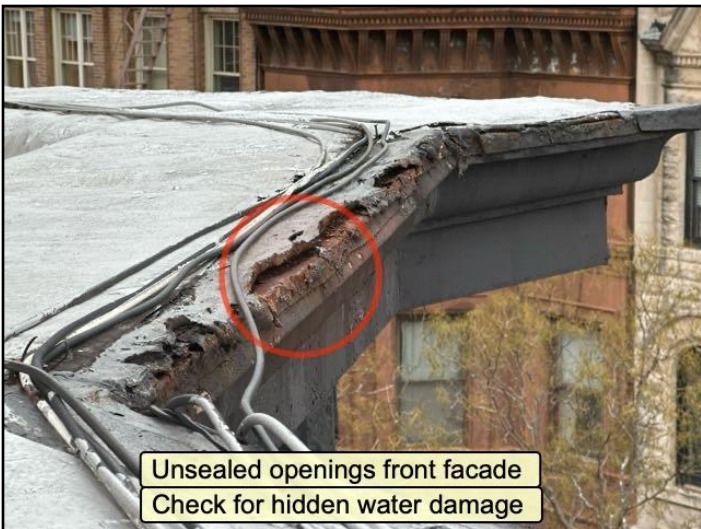
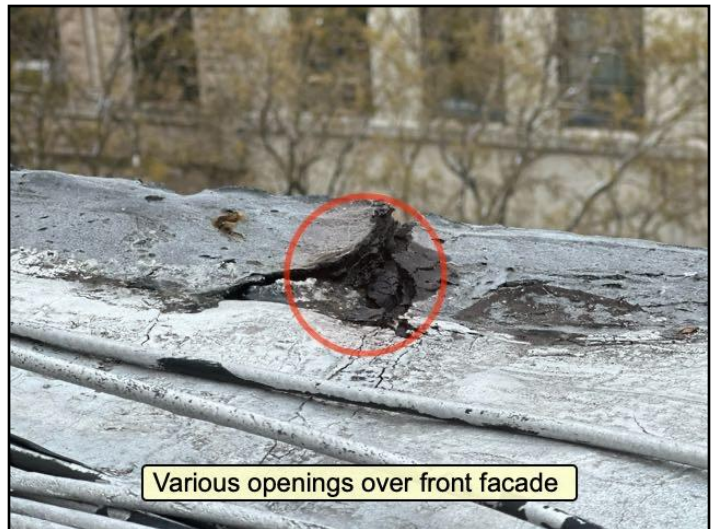
6. Condition: • Past life expectancy

Past life expectancy

****RECOMMEND FURTHER EVALUATION OF FRONT FACADE PRIOR TO PURCHASE****

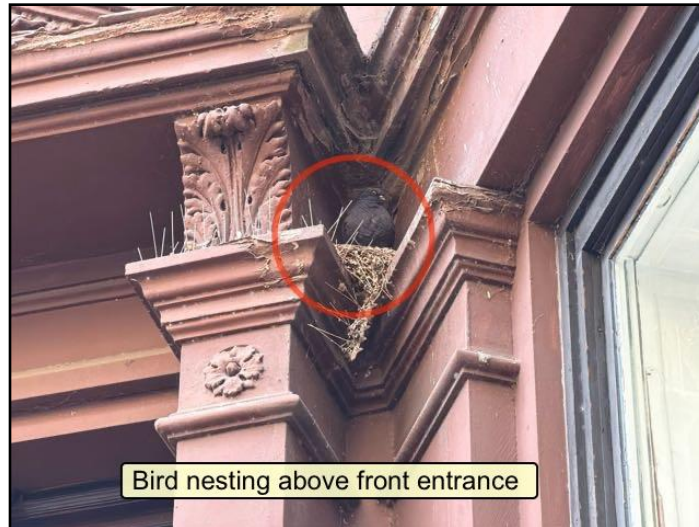
Location: Front

8. Condition: • Birds nesting

Birds nesting material

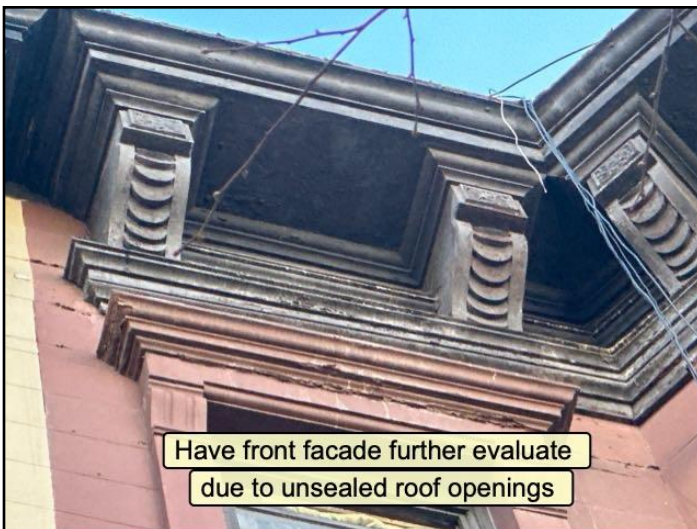
9. Condition: • General

Ask seller for recent facade inspection

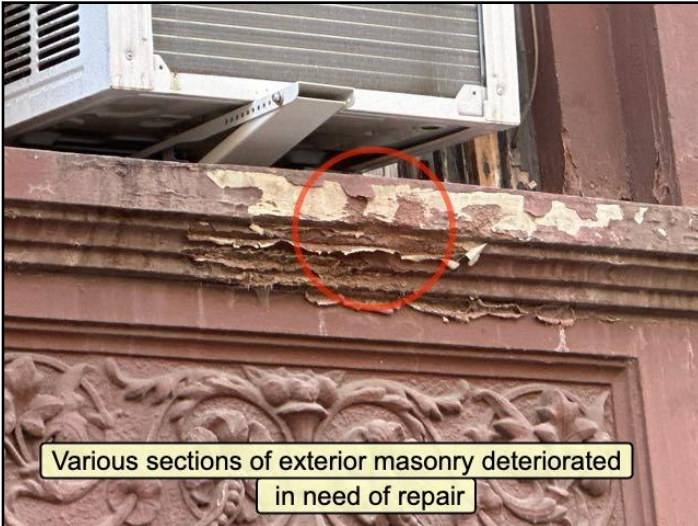
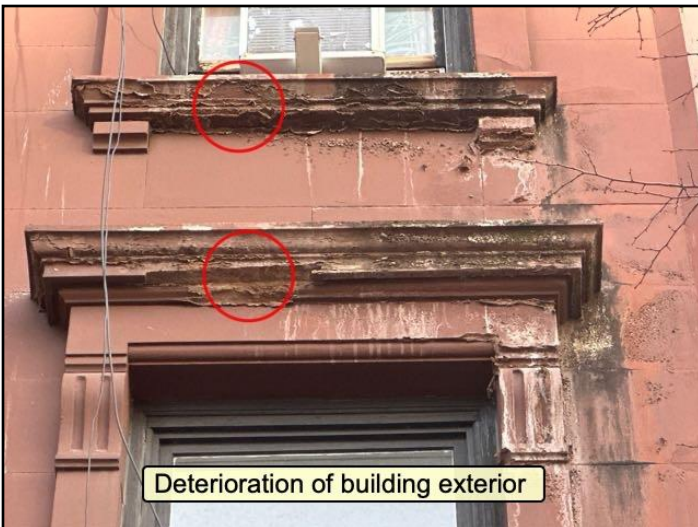
13. Condition: • [Masonry deterioration](#)

Masonry deterioration

****RECOMMEND GETTING ESTIMATE FOR ALL NEEDED EXTERIOR REPAIRS****

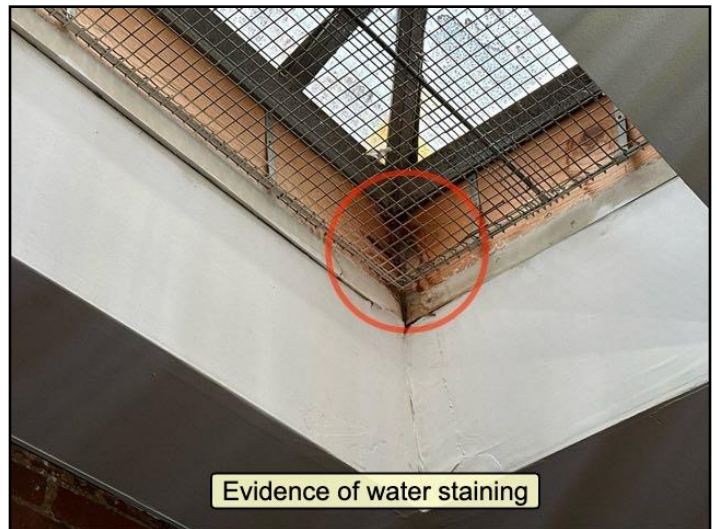
Old

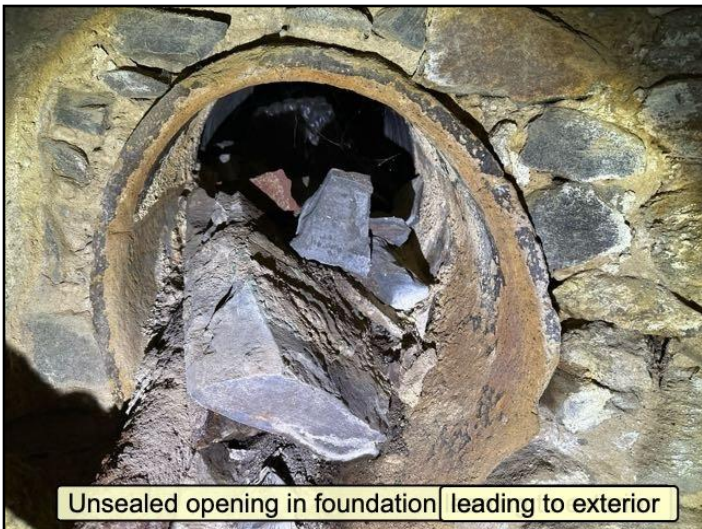
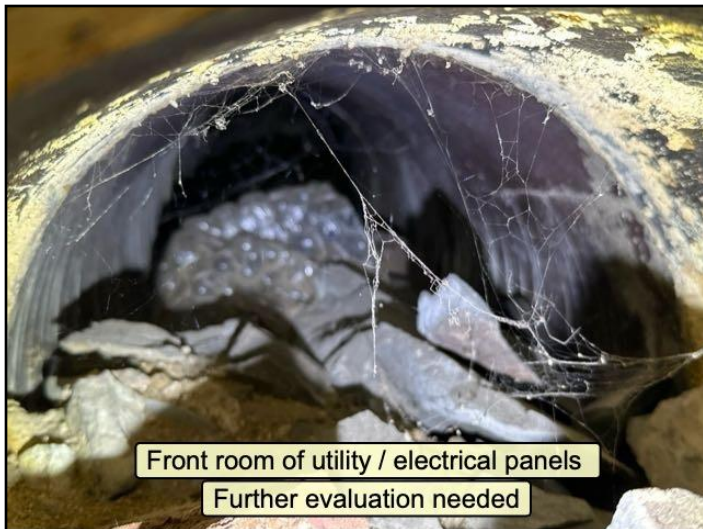
Further evaluate

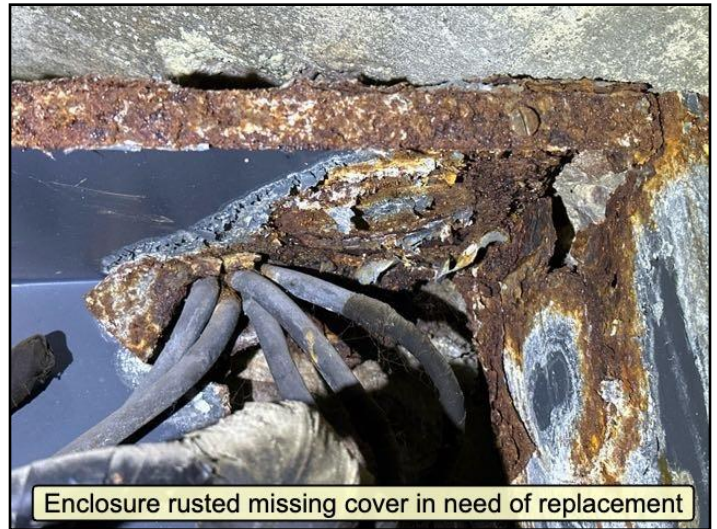
WIRES EXPOSED

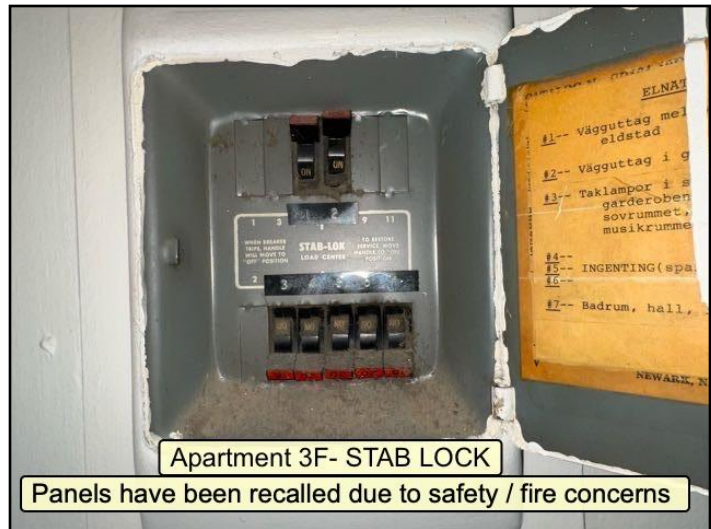
Apartment 3F- STAB LOCK

Panels have been recalled due to safety / fire concerns

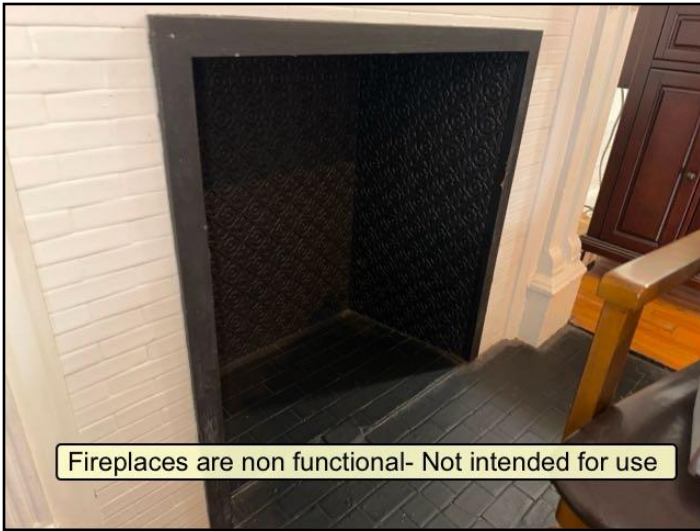
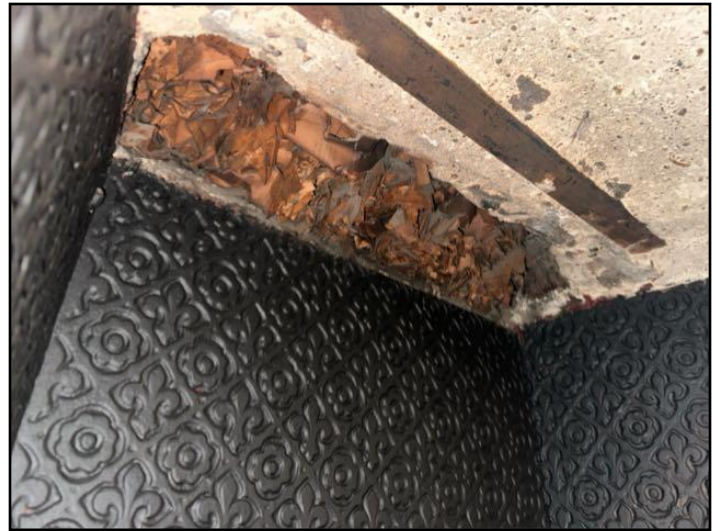
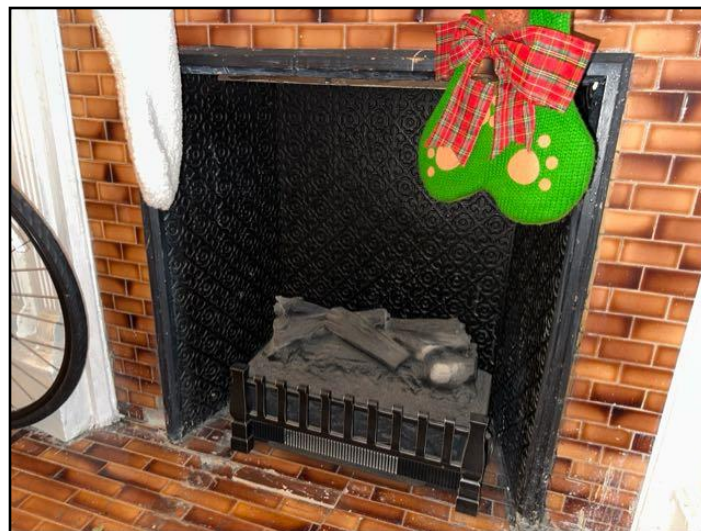
Non-functional

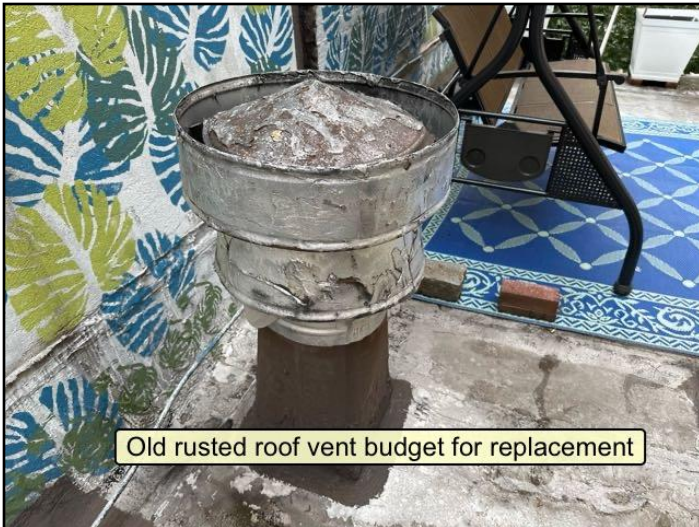
33. Condition: • Rust

Rust

Task: Replace

Time: As soon as practical

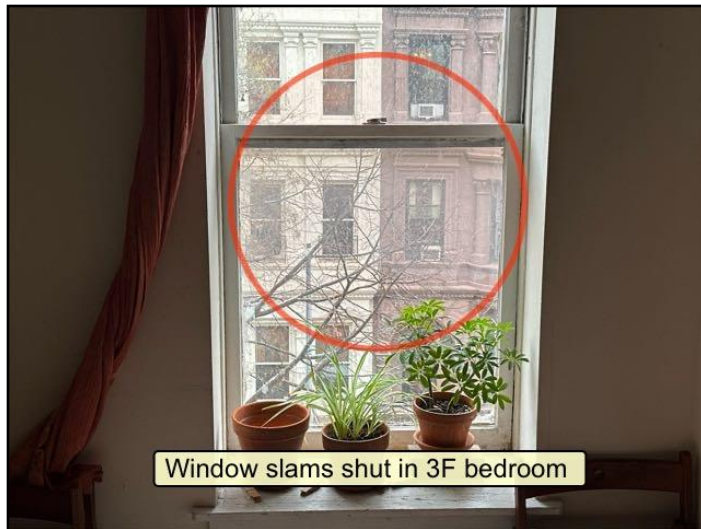
43. Condition: • Slams shut

Slams shut

Task: Replace

Time: As soon as practical

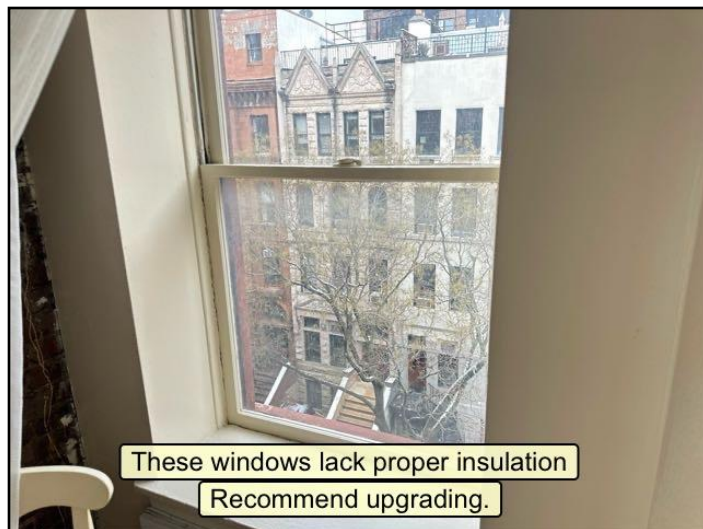
44. Condition: • Old single pane glass

Various windows throughout building are old with single pane glass. These windows lack proper insulation. Recommend upgrading.

Old single pane glass

Recommend budgeting for replacements

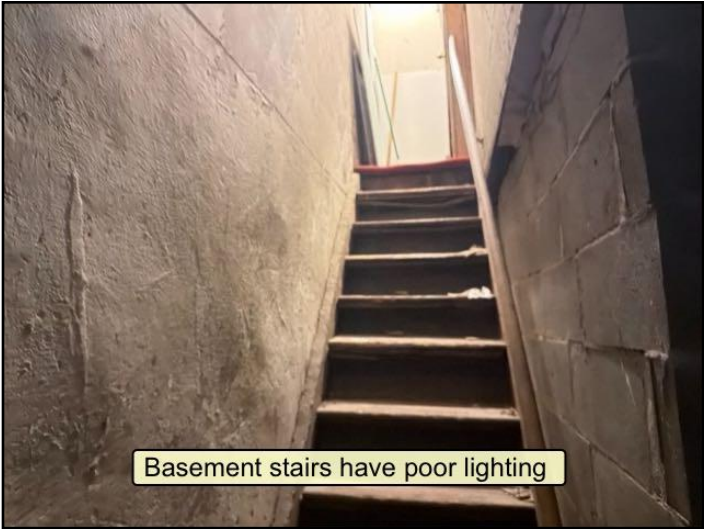
47. Condition: • [Poor lighting](#)

Implication(s): Trip or fall hazard

Poor lighting

Task: Improve

Time: As soon as practical
